Bridge assessment: A case study of Ajaokuta-Itobe Bridge, Kogi State Ibrahim

World Journal of Advanced Engineering Technology and Sciences, 2021, 02(02), 066–078

This report summarizes the assessment carried out as a result of the public uproar on the degree of safety of the Ajaokuta/Itobe Bridge in Kogi state. The public outcry was as a result of a severe damaged expansion joints of the bridge. Visual inspection and concrete strength test were carried out to ascertain the safety condition of Itobe Bridge. Seven out of the total number of eight expansion joint covers were damaged and out of place while all the elastomeric bearings were in good working condition. The scouring of the river bed was not visually pronounced except little at the abutment side of the Abuja-Ayingba approach which is attributed to change of water course. Farming activities within the vicinity of the bridge embankment has no effects on the bridge foundation. The compressive strength test result of some bridge elements selected shows that the values are within the satisfactory range. The assessment recommended the lengthening and desilting of the drainage pipes to prevent further corrosion of the concrete a

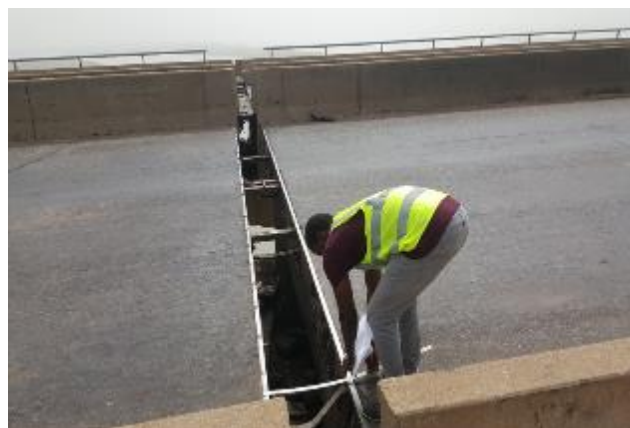
Plate 4 Measurement of exposed expansion joint

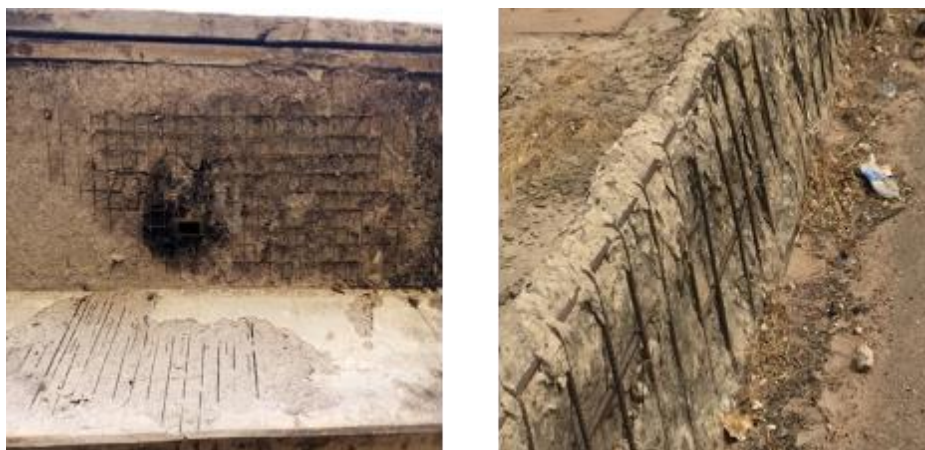
The reinforcement and wire mesh were exposed at the bottom of bridge deck towards Abuja approach which showed sign of early state of corrosion at certain places as shown in Plate 7 below. This was due to extensive fire impact as a result of burnt trees under the deck. The corrosion of the reinforced bars may be as a result of damaged/blocked drainage pipe as shown in picture below.

Plate 7 Corrosion of reinforcement bars at the soffit of deck.

- Lengthening and desilting of the short blocked drainage pipes which are directly discharging water on the concrete deck should be done in order to prevent further corrosion of the deck.

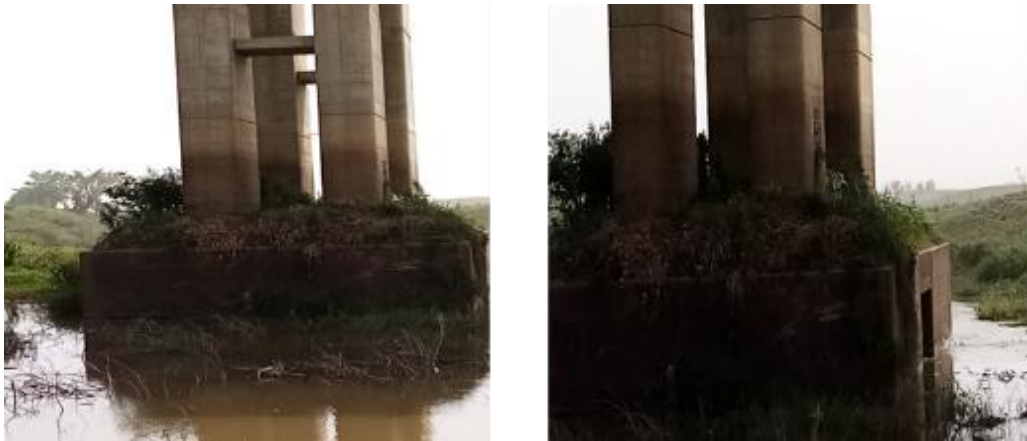
Scouring is the engineering term for the erosion of soil surrounding a bridge foundation (pile caps and abutments). Bridge scour occurs when fast-moving water around a bridge removes sediment from the bridge foundation, leaving behind scour holes. In the case of Itobe Bridge there was no visible scour action around the bridge substructure except at span No2, Ayingba approach, as shown in Plate 9. Erosion and gradual wash out was observed at some part of Abuja approach embankment as shown in Plate 10 below.

Plate 9 Scouring action exposing the pile cap No 2

- The missing steel pipe handrails on the reinforced concrete bridge needs to be replaced and properly anchored to the deck.
- The use of sheet piles filled with compacted sand or gabions should be provided around the exposed piles cap to protect further deterioration of the foundations.

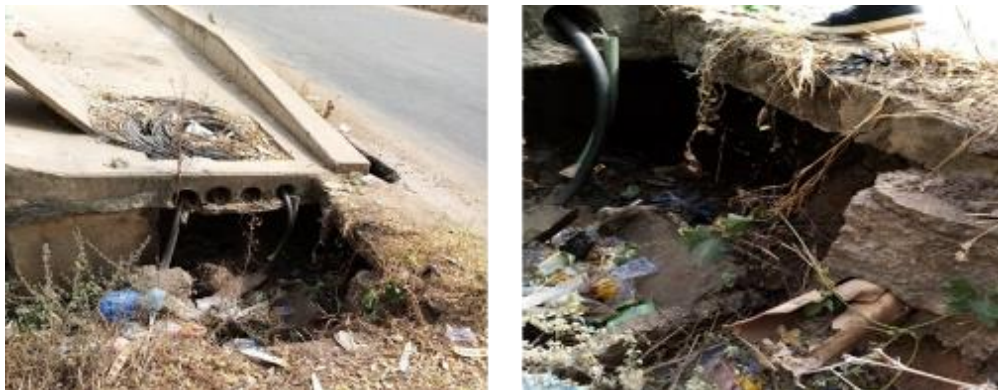
Plate 10 Erosion action exposing part of Abuja approach Abutment

- The eroded embankment should be filled and compacted with the right fill materials and also shoreline protection measures should be deployed to protect the bridge embankment.

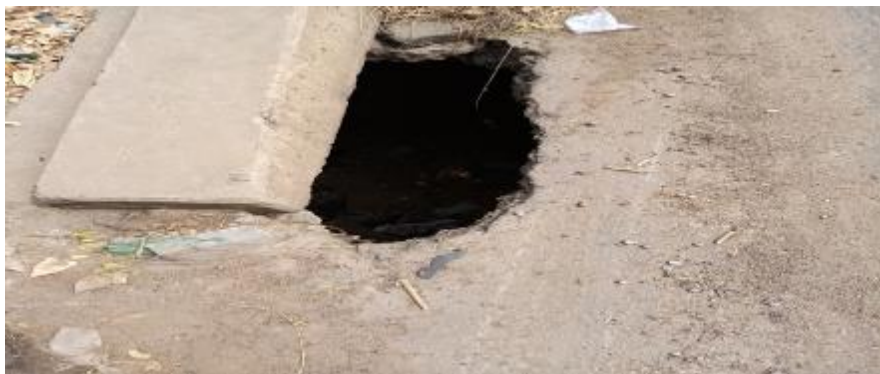
Plate 11 Erosion action exposing part of Abuja approach Abutment

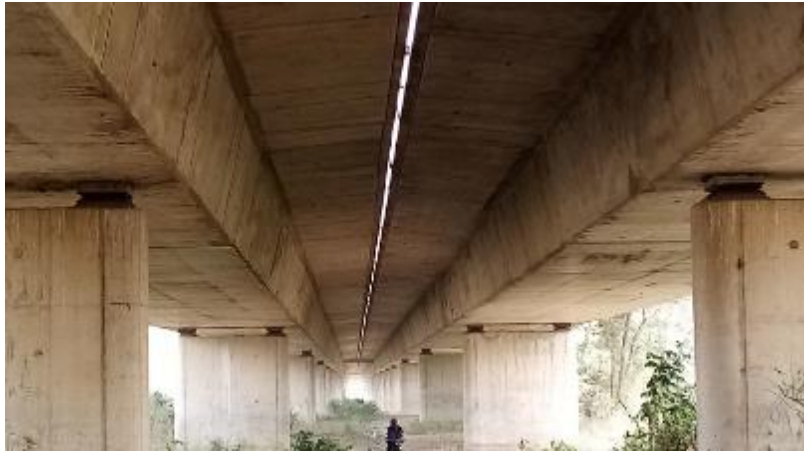
Visual inspections of the bridge bearings confirmed that the bearings are in good working condition. A typical inspection is shown in Plate 12 and 13.

Plate 12 Drone captured images showing bearings of the Itobe Bridge

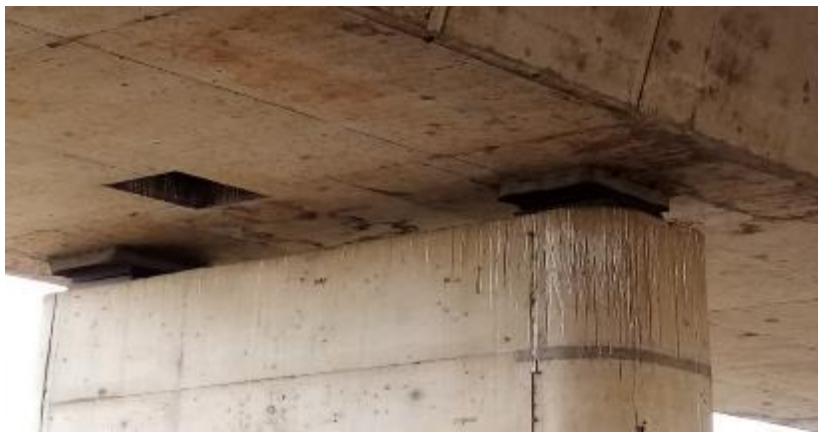
Plate 13 Showing bearings of the Itobe Bridge

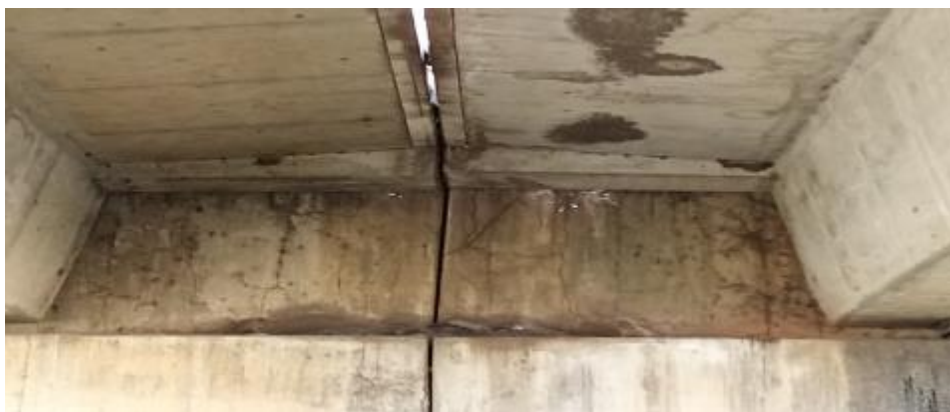
Minor vertical and diagonal cracks were noticed at the abutment's walls and walkway of Itobe Bridge. Cracking is an inherent aspect of reinforced concrete and, if properly controlled, should not be detrimental to the performance of the structure (Kozikowski and Suprenant, 2015). The cracks on the bridge were measured to be less than 0.5 mm wide as shown in Plate 12 to 13 which fall within acceptable value of 0.4 mm as stipulated in BS EN 1992-1-1:2004.

Plate 16 Minor cracks at the abutment of Abuja-Ayingba approach

- Maintenance works required to seal cracks on the reinforced concrete abutment and piers should be carried out.
- Maintenance works required to repair the damaged parts of the concrete deck by thorough cleaning of the surface to remove all deteriorated concrete down to sound concrete and building the surface back to grade.

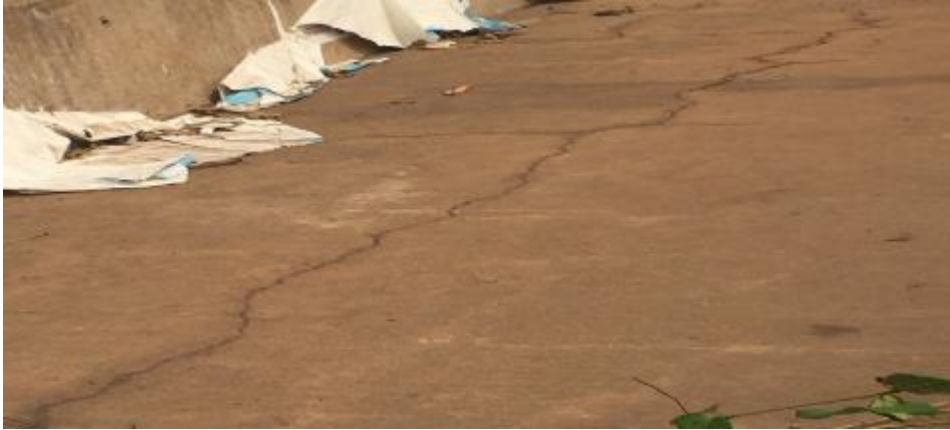
Plate 17 Cracks at walkway of the bridge on Ayingba - Abuja approach

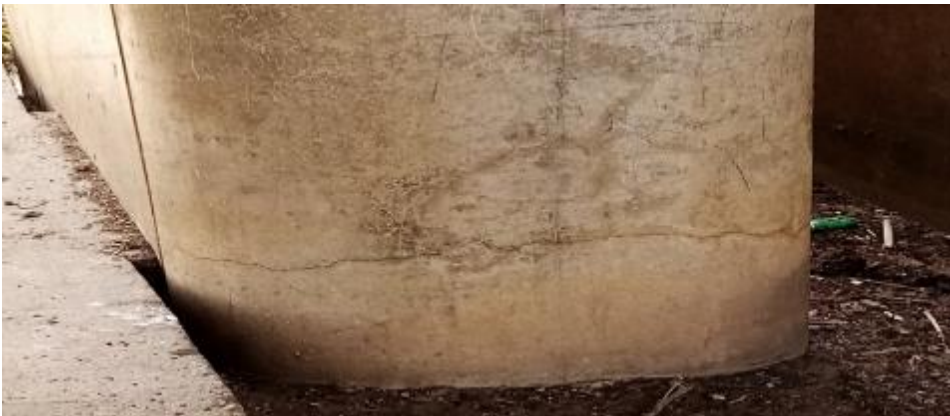
Plate 18 Crack identified on the pier foot of the Itope Bridge.

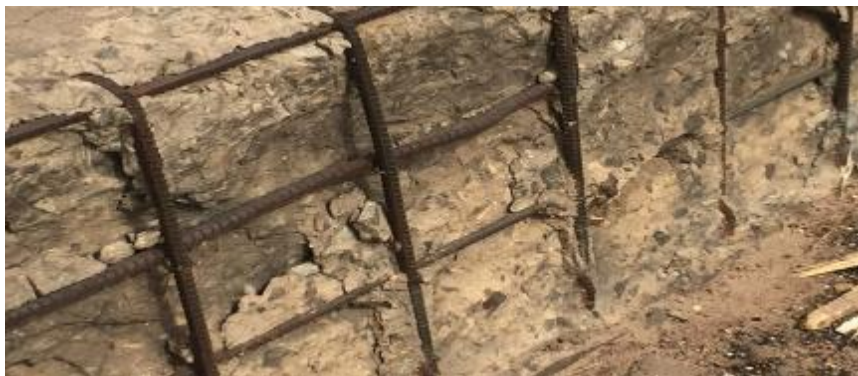
Spalling of concrete pedestrian walkway protector was observed as shown in Plate 19. Spalling is the peeling off of concrete cover thereby exposing the reinforcement which then leads to corrosion, and represents a serious defect in the concrete, in that the reinforcement can become corroded. On Itope Bridge spalling of concrete was observed at the top and soffit of the bridge deck which was as result of bush fire burning from beneath the bridge. The incidence occurred few months ago according to an eye witness account.

Plate 19 Concrete spalling on the pedestrian walkway protector.

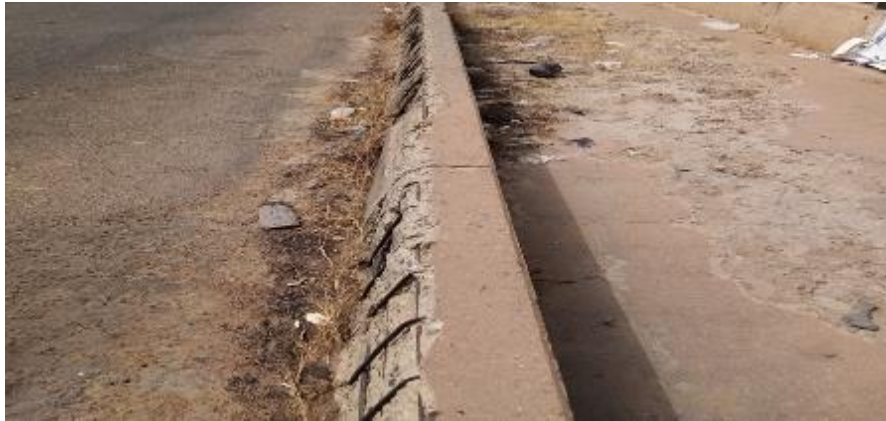
Plate 20 Spalling observed on pedestrian walkway section.

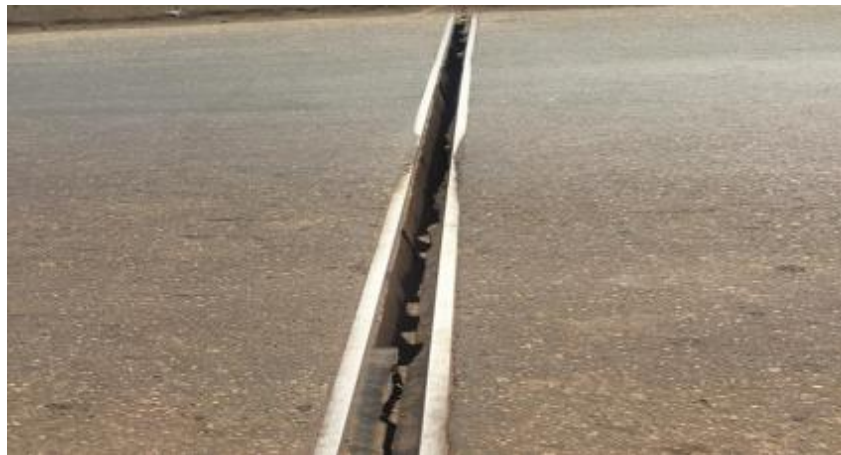
Expansion joints are one of the major components of bridge as it allows movement between the decks while accommodating shrinkage and temperature variations on reinforced or prestressed concrete. Itobe Bridge has a total of 8 expansion joints and it was observed that 7 were completely damaged. All the expansion joint were believed to be strip seal expansion joint. An elastomeric strip seal system consists of a preformed elastomeric gland mechanically locked into metallic edge rails generally embedded into the concrete deck on each side of an expansion joint gap. The strip seal expansion joint at the free moving end of the bridge deck (Ayingba approach) is in fair working condition, with little damages on the elastomeric strip seal as shown in plates 21 to 22 below. The damage of the elastomeric expansion joints as shown in plate 23 to 27, it may be due to either aging or displacement of the bridge deck under loads. The width of the 7 damaged expansion joints gap were between the ranges of 47cm to 53cm wide.

Plate 22 First expansion joint from Ayingba Approach with damaged elastomeric seal

- The damage of the elastomeric expansion joints may be due to either aging or displacement of the bridge deck under vehicular loading.
- The cracks on the bridge were measured to be less than 0.5 mm wide which fall within acceptable value of 0.4 mm as stipulated in BS EN 1992-1-1:2004.

- The expansion joints should be fixed with proper elastomeric or steel strip materials to protect the structure from further deterioration.
- Expansion joint devices are highly susceptible to vehicular impact that results as a consequence of their inherent discontinuity hence the need for more frequent routing maintenance.

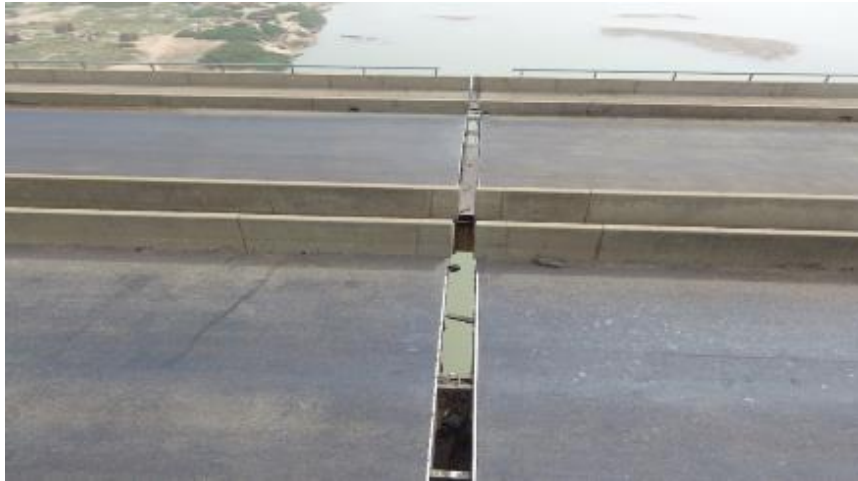
Plate 23 Drone image showing missing expansion joint cover of Itope Bridge.

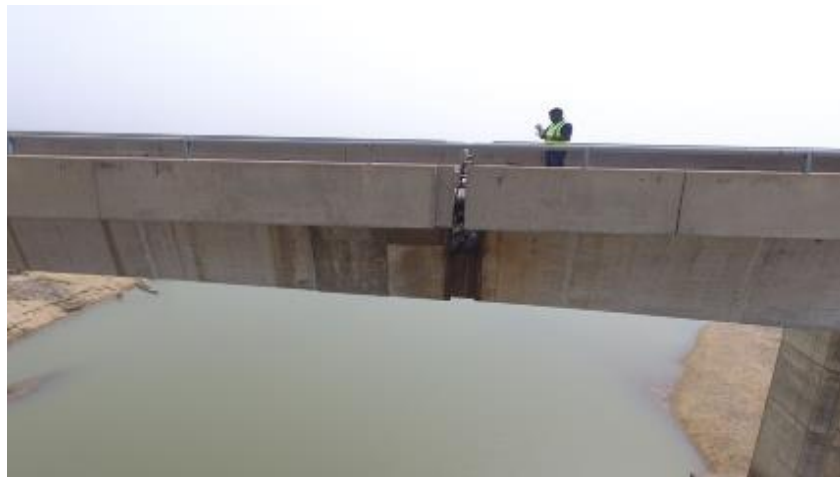
Plate 24 Drone image Showing missing expansion joint cover of Itope bridge

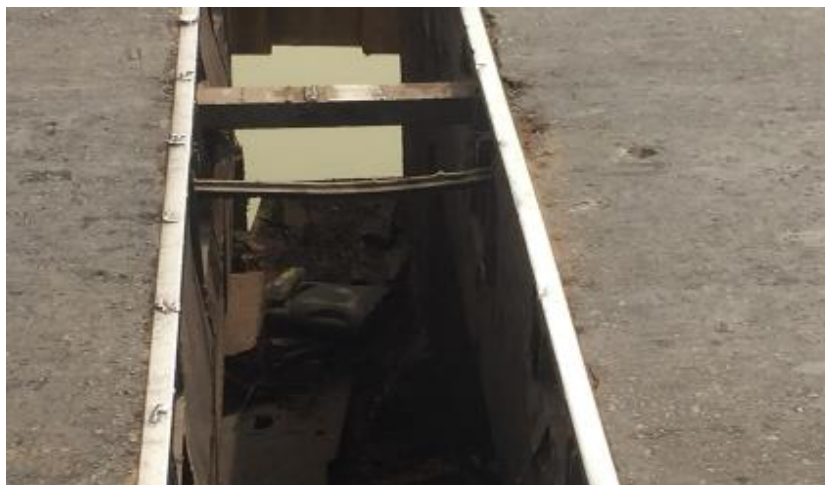
Plate 25 Showing opening of expansion joint

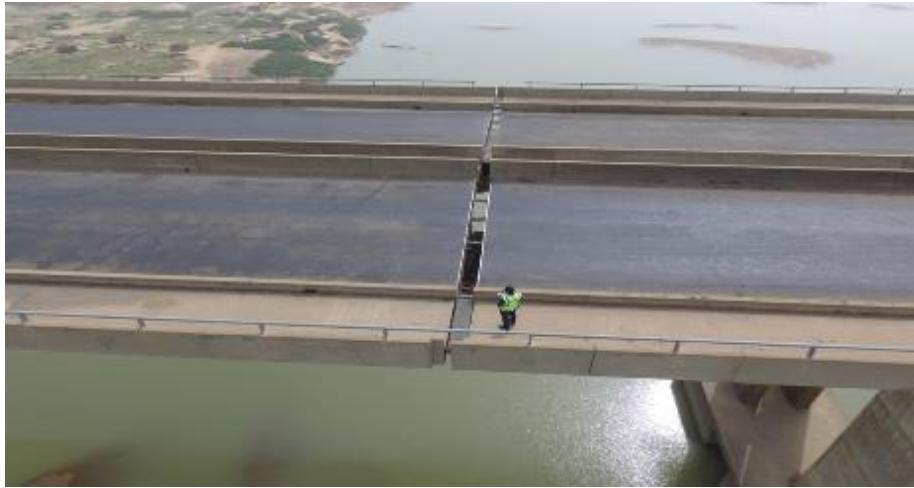
Plate 26 Drone Image Showing opening of expansion joint

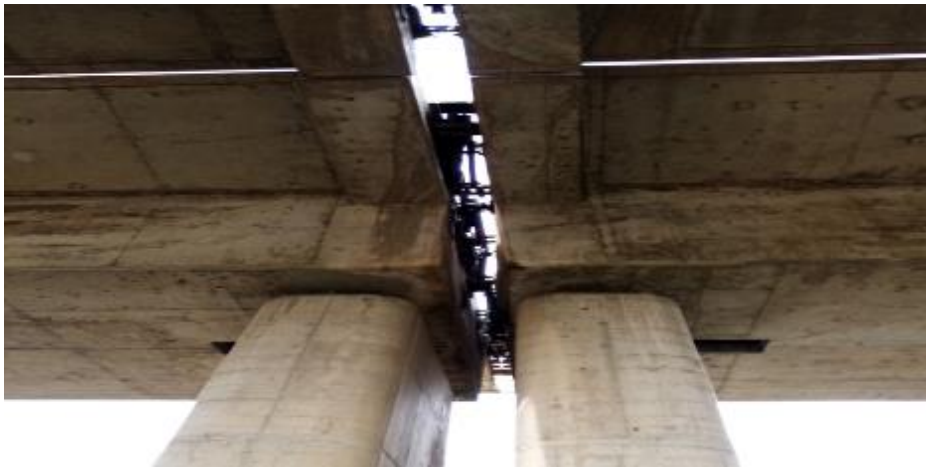
Plate 27 Image showing opening of expansion joint from the below the deck.

- Seven out of eight expansion joint devices are damaged therefore exposing the elements of the structure that are otherwise protected by the joint devices. The openings about 47cm-53cm becomes a conduit by which moisture, abrasives, chemicals, and other debris are deposited on the superstructure and substructure below the opening, thereby causing extensive damage.

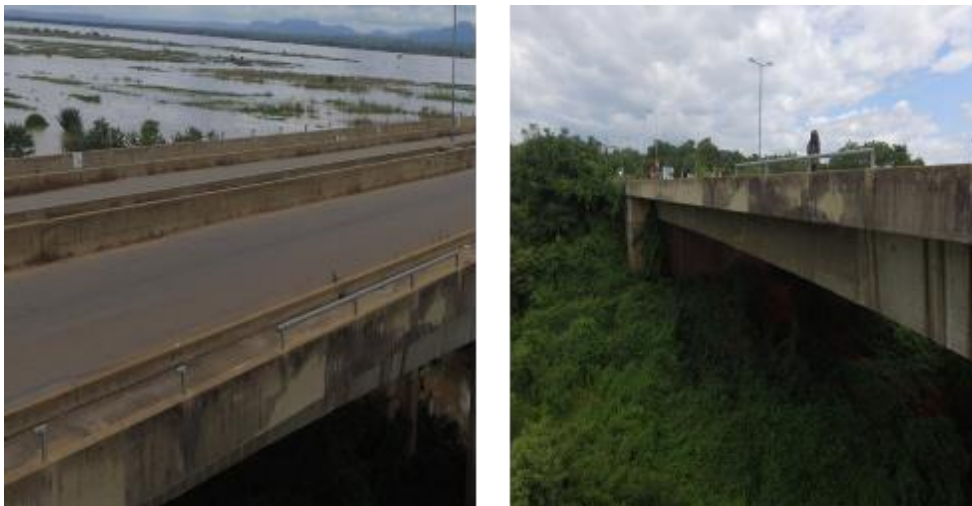
A total of about 800 meters length of steel pipe handrails were missing at both sides of Itohe Bridge as shown in Plate 24 and 25 below.

Plate 24 Image showing missing handrails.
