## Community water supply project in Ikuru Town, Andoni, Rivers State: performance and challenges

World Journal of Advanced Engineering Technology and Sciences, 2022, 05(01), 032–038

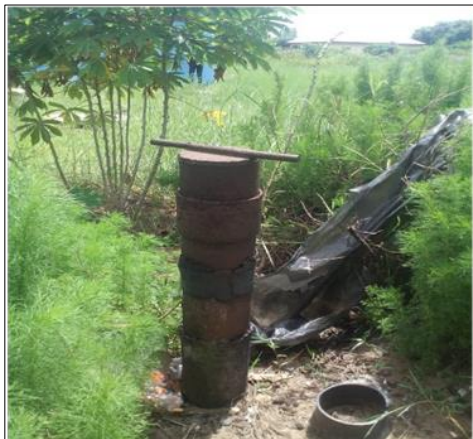
**Figure 2a** The Deep Well for water abstraction

The new water project has served the community for a few seven months since it started operation in January 2021. The source of this water project is from a deep well of a coastal aquifer (Figure 2a). The upper part of the casing is capped with iron pipe and extends at least 0.6m above ground with a diameter of 0.3meter. The first treatment process is aeration. The type of aerator used in the Ikuru treatment plant is a cone aerator (Figure 2b). It oxidizes iron and manganese as a pretreatment measure. The aerator is of concrete- type with three stacked pans arranged such that water fills from the top pan and cascades down to each of them, down to the chemical system. This treatment unit uses two solution tanks and three different chemicals shown in Figure 1c. They are chlorine, calcium hypochlorite (HTH-High Test Hypochlorite), and aluminum sulfate. Water from the aerator flows through a plumbing system to a chlorine solution tank with a capacity of 15 gallon. It then moves to another 15-gallon capacity solution tank of alum and lime. The solution tank is for coagulation and water softening. The final treatment unit is a filtration system that consists of a pressure filter of 4 m in diameter, made of coated steel. At this unit, the operators believed that the treated water had attained a certain level of purification. There is no water analysis to test the quality of water before and after treatment. After the completion of the water treatment process, water flows to the overhead tank with the help of the high lift pumps. The capacity of the elevated tank is 50,000litre (Figure 2d). The pumping of water is two times a week. It takes 24 hours to fill the tank to serves the community for three days before the next pumping. A lister-generator is used to power the operation of the treatment system. The water flows out through water points placed at different locations within the community.

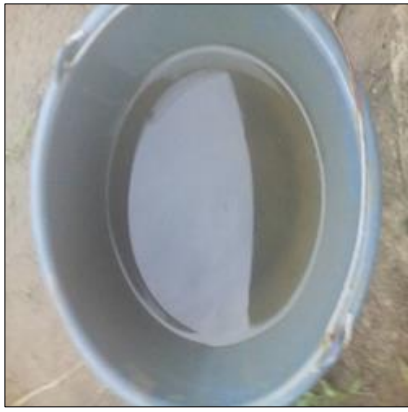
Figure 3a before treatment

Water sample in Figure 3a showed high levels of turbidity with an oily sheen and so can protect microorganisms from the effects of disinfection, stimulate the growth of bacteria, and exert a significant chlorine demand. Where disinfection is practiced, the turbidity must always be below 5 NTU and ideally below 1 NTU for effective disinfection. The colour of the water in Figure 3b is initially clear after treatment but turns orange-brown colour over time in Figure 3c. The colour resulted from the presence of dissolved ferrous iron and the condition is known as the reduced form of iron metals. Anaerobic groundwater may contain ferrous iron at concentrations up to several milligrams per litre without discoloration or turbidity in the water when directly pumped from a well [10]. On exposure to the atmosphere, however, the ferrous iron oxidizes to ferric iron, giving an objectionable reddish-brown colour to the water. These reduced forms of iron and manganese are most common in groundwater with a pH of less than 7.0.

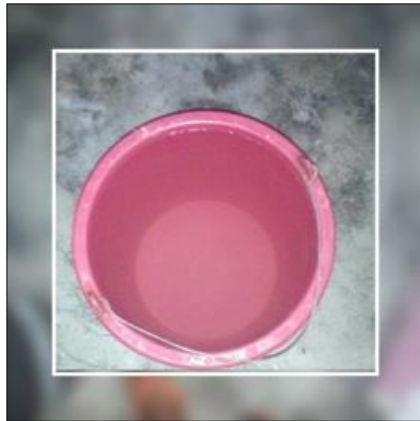
Figure 3b after treatment

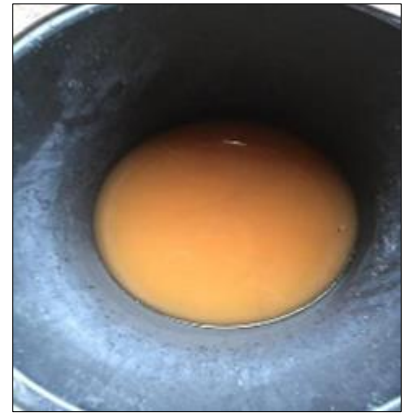
Figure 3c after two days of standing
