Case study of bearing capacity failure in a 4-story reinforced concrete building

World Journal of Advanced Engineering Technology and Sciences, 2024, 13(01), 892–898

This case history analyzes the bearing capacity failure of a 4-story reinforced concrete building in Benghazi, Libya, constructed in Fall 2000. The building has a plan area of 65 m² and is supported by an 80 cm thick raft foundation resting on collapsible sandy loess, which can lose shear strength when wet.

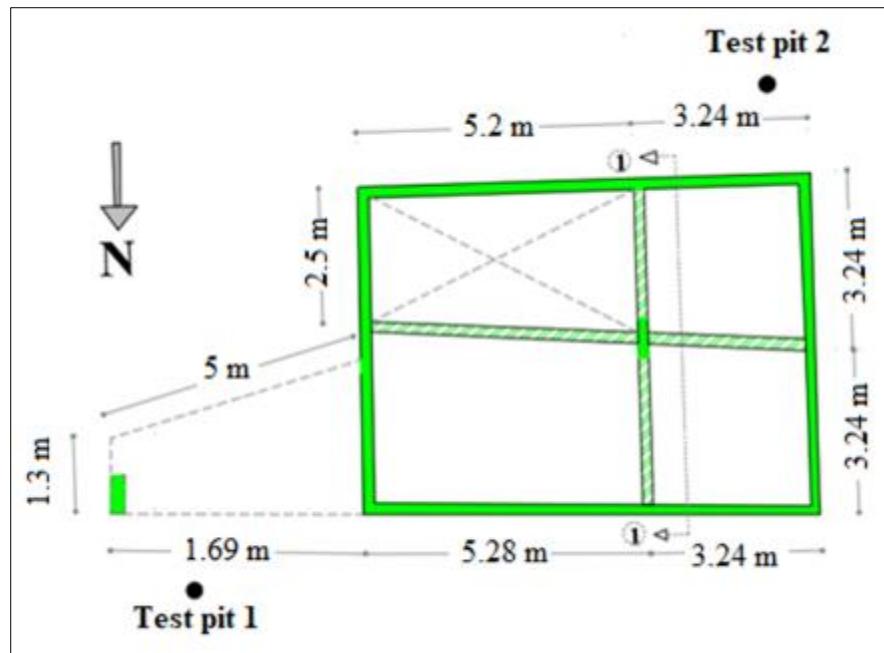
Figure 1 Plan of ground floor

To evaluate the soil properties for the tilted building, traditional borehole methods were deemed risky, prompting the excavation of two test pits as shown in Fig 1 (test pit 1 at 2.0 meters and test pit 2 at 3.2 meters). Undisturbed soil samples were collected using Shelby tubes for analysis. Tests conducted as per ASTM standards, included soil classification via the Unified Soil Classification System (USCS), moisture content, specific gravity, liquid limit, plastic limit, plasticity index, cohesion, angle of internal friction, and unit weight [3,4,8,9]. Test results are summarized in Table 1. The findings indicated that the upper soil layer comprises reddish-brown, loose to medium-dense sandy loess.

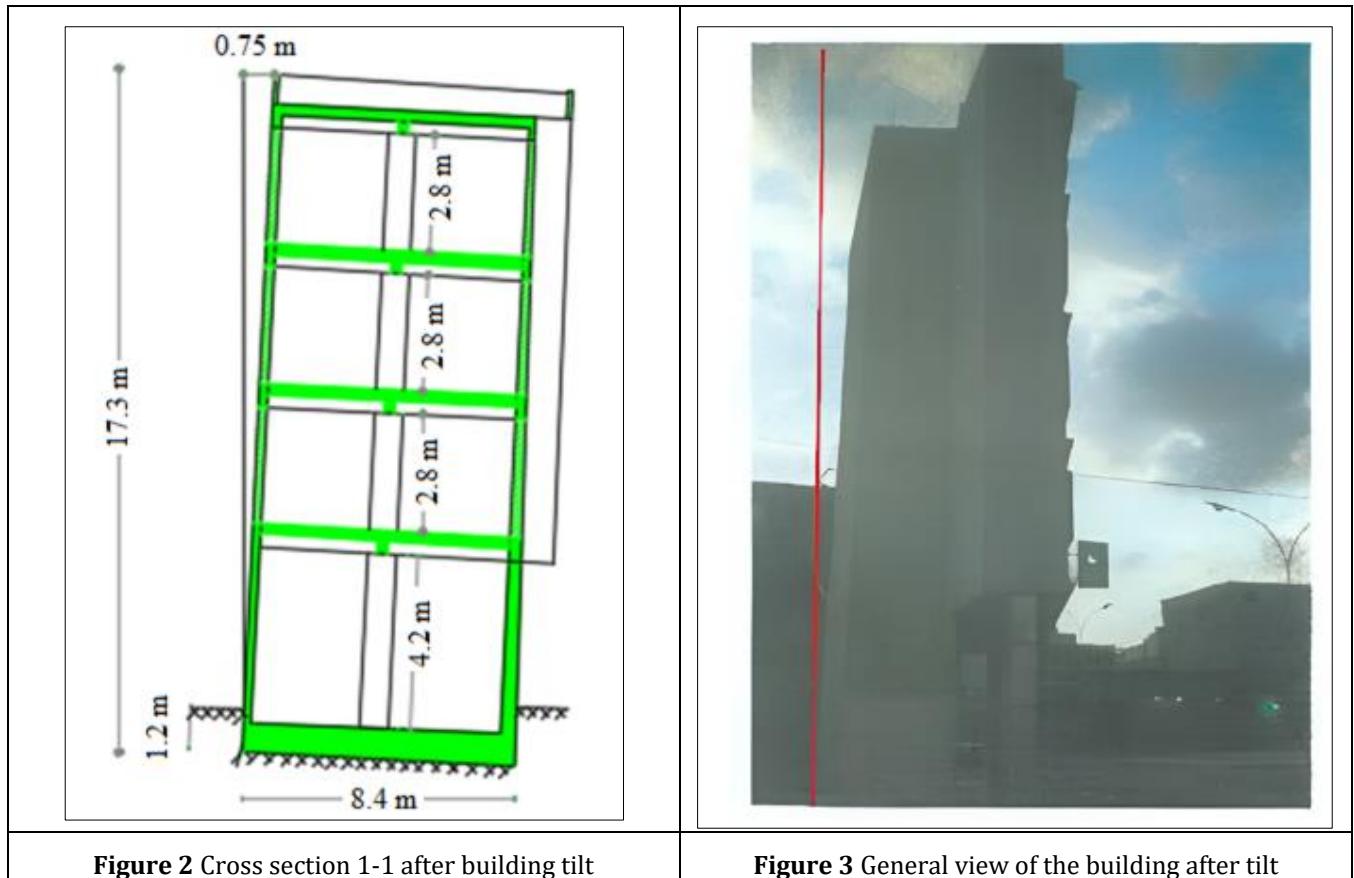
Figure 2 Cross section 1-1 after building tilt

In winter 2002, as a result of the reduced bearing capacity, the structure experienced tilting predominantly towards the north. Despite this significant movement, inspections of the structural elements revealed no cracks or signs of distress. This observation can be attributed to the rigidity of the raft foundation and the reinforced concrete shear walls on the ground floor, which effectively maintained the integrity of the structure even as it settled unevenly.

Despite a significant tilt towards the north, a detailed inspection of the structure revealed no visible cracks or deformation. This resilience is attributed to the building's rigid foundation and well-designed reinforced concrete facade walls, which allowed for rotation without excessive stress on the superstructure.

Moreover, the slenderness shape of the building and the asymmetry of the raft foundation increases the overturning moment, reducing stability and making it more vulnerable to potential overturning events. This precarious situation required immediate action to ensure safety, especially while awaiting further evaluation or demolition.

To address the instability, 100 kN of sandbags were evenly placed on all floors, particularly on the south side, to help mitigate the tilt and improve stability. The building was also continuously monitored using surveying equipment to detect any additional movement, ensuring the safety of nearby personnel until a decision about demolition could be reached. This proactive strategy underscores the significance of thoughtful weight distribution and ongoing monitoring in managing compromised structures.

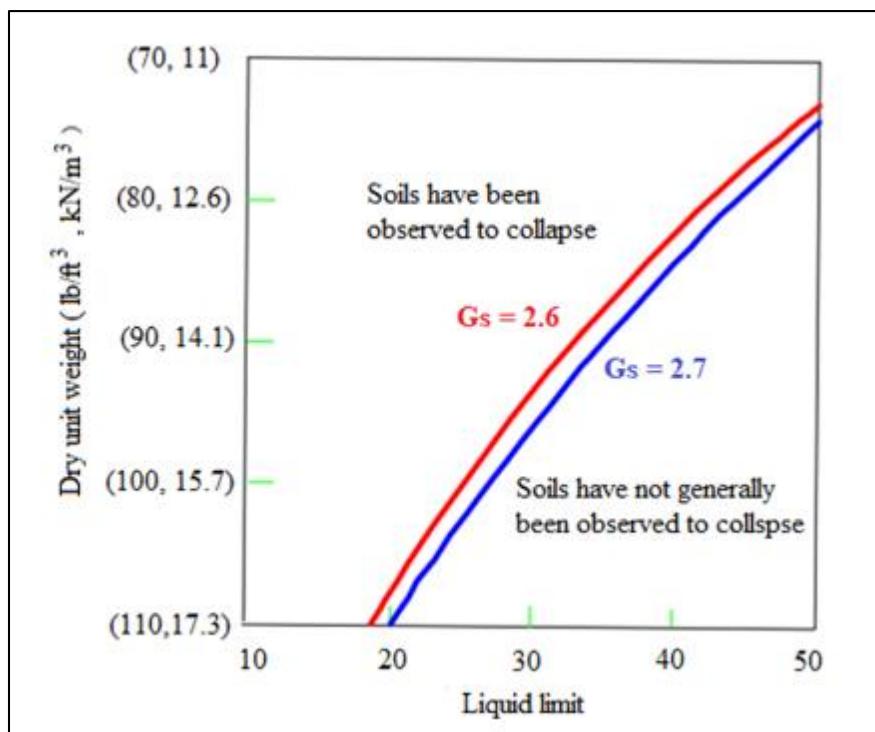
**Figure 4** Collapsible and non collapsible loess

Fig 5 displays a graph of limiting dry unit weights plotted against their corresponding liquid limits. For any given soil, if the natural dry unit weight is below the limiting line, it is likely to be collapsible, as noted by Holtz and Hilf [5]. The chart clearly indicates that the supporting soil can be classified as collapsible based on its characteristics.

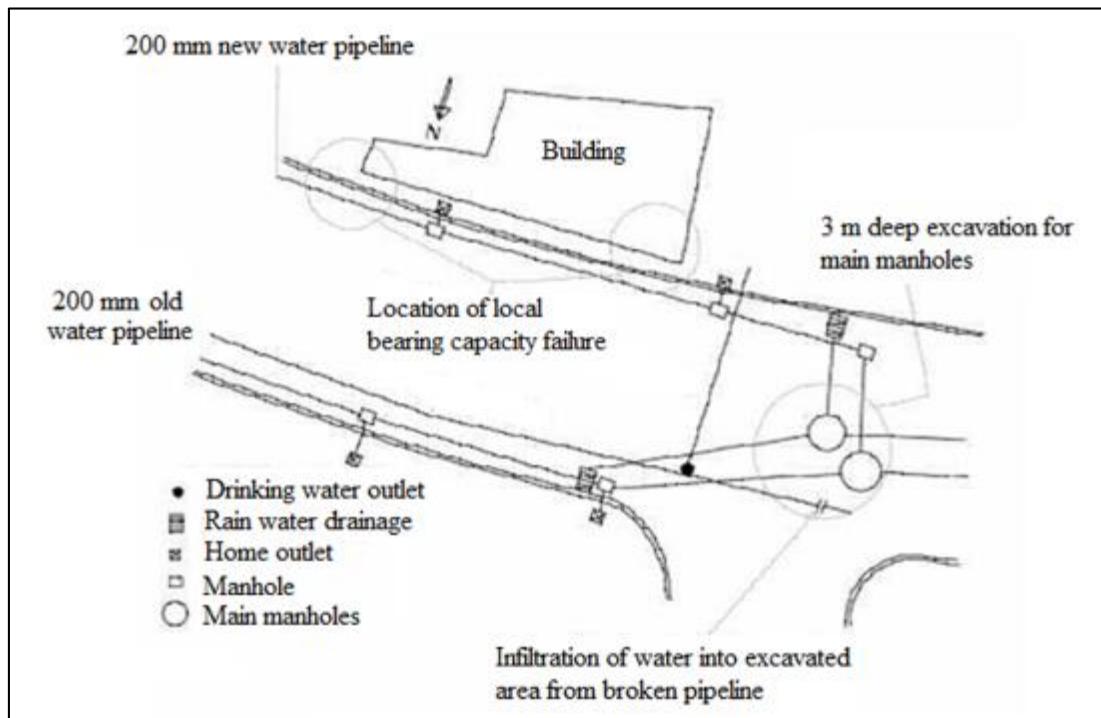
Figure 5 Location of building, the excavation for infrastructure and broken old pipeline

In Spring 2002, a local construction company began infrastructure work on Al-Mehdawi Street, including sewage and water pipeline installation and manhole construction up to 2 meters deep, located near an existing building's foundation. This was done without necessary precautions, posing significant risks to the building's structural integrity.

During construction, which ended in Fall 2002, witnesses reported severe water leakage and flooding, leading to destabilized soil conditions. Test results from test pit 1 indicated about 80% moisture saturation, while test pit 2 showed only damp conditions. This difference in moisture content critically affected soil behavior, with test pit 1 exhibiting reduced shear strength due to saturation, increasing the risk of failure.

The disturbances from the construction activities adversely affected the supporting loess, causing localized shear failure beneath the building's north side. These events highlight the need for careful planning and protective measures in construction near existing structures. The resulting soil saturation not only jeopardized the stability of the supporting soil but also raised concerns about the building's long-term viability. Proper geotechnical assessments and construction practices are essential to prevent such issues and ensure structural safety.

Excavation work near the building foundations, reaching depths of 1 to 3 meters, was performed without necessary precautions, further reducing the soil's shear strength by disrupting its natural structure and allowing more water to infiltrate. This lack of protective measures destabilized the soil and worsened conditions for potential failure. Excavation near buildings on sandy or silty soils should be approached with extreme caution, implementing protective measures like sheet piling to maintain soil stability and prevent disruption. Additionally, effective drainage systems should be established around the foundation to minimize water infiltration, thereby reducing the risk of saturation.

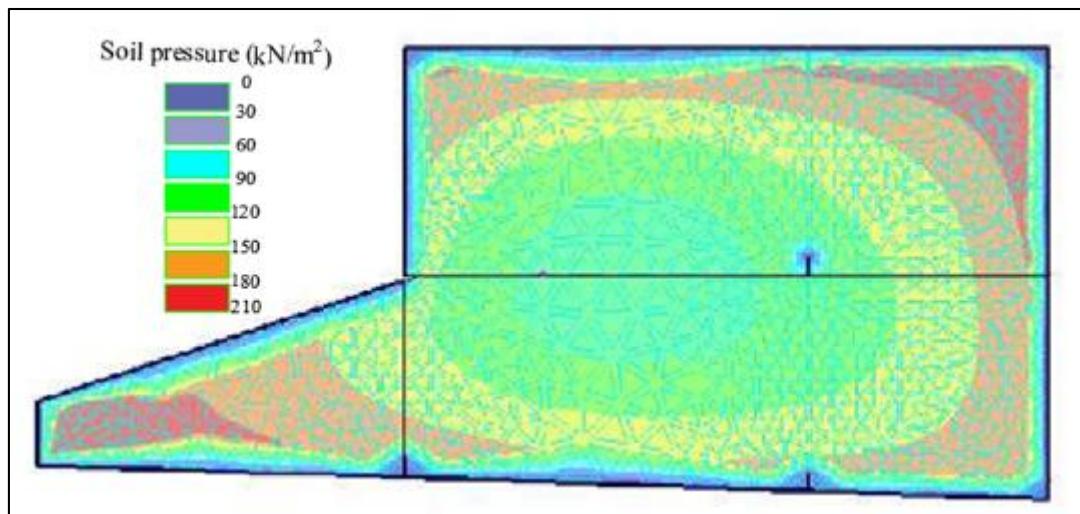
Figure 6 Soil pressure underneath foundation (finite element method solution)

The analysis found a net ultimate bearing capacity of 147 kN/m^2 at test pit 1, compared to 300 kN/m^2 at test pit 2, highlighting a nearly 50% decrease at test pit 1 due to higher moisture content. This saturation can significantly impair load-bearing ability, emphasizing the need to consider environmental factors in construction.

Correlation data showed that the service pressure at test pit 1 exceeds its bearing capacity, indicating a risk of structural failure, while test pit 2 remains safely within limits. To mitigate risks associated with collapsible soils, effective drainage, controlled construction activities, and careful excavation practices are essential. Implementing these measures can enhance the safety and longevity of structures on challenging soil types.
