Automated potholes detection using vibration and vision-based techniques

World Journal of Advanced Engineering Technology and Sciences, 2023, 10(01), 157–176

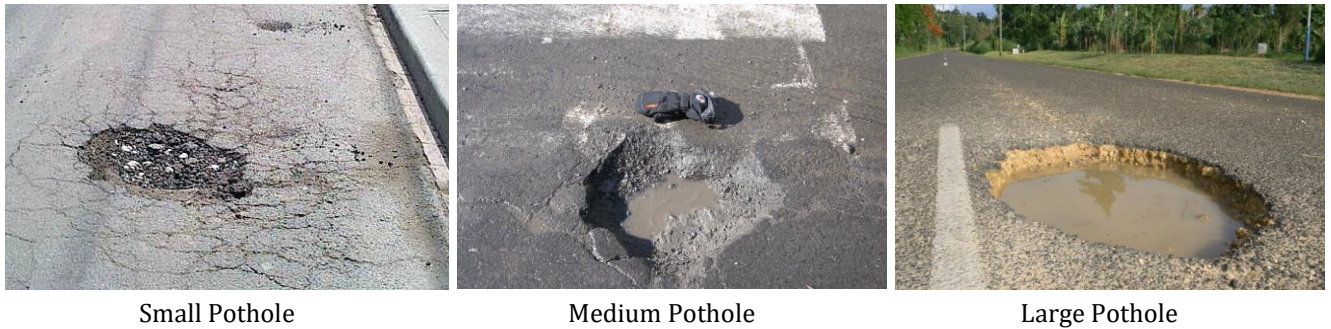
Figure 1 Photos of Different Severity of Potholes

Potholes are concave deformations that vary in size and display a bowl-like shape in the bituminous surface or that extend into the binder/base course. These formations result from the pavement materials' localized disintegration. Figure-1 shows severity of potholes.

Potholes are categorized into three sizes: small, medium, and large. A small pothole measures 25 mm deep and 200 mm wide.

A medium pothole ranges from 25 to 50 mm in depth and 500 mm in width. Large potholes are more than 50 mm deep and 500 mm wide.

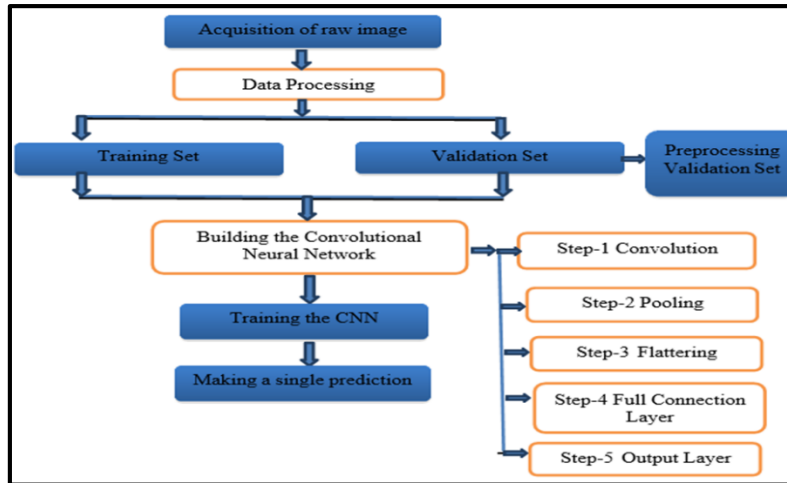
Figure 5 Methodology of CNN algorithm

A Convolutional Neural Network (ConvNet/CNN) stands as a formidable algorithm within Deep Learning, designed to process input images and allocate significance (via learnable weights and biases) to various components or objects present in the image, effectively distinguishing between them. Figure-5 shows methodology of CNN algorithm. This model is highly versatile, adept at handling one-dimensional, two-dimensional, and even three-dimensional image data. Notably, ConvNets demand considerably less pre-processing compared to alternative classification methods. Instead of manual filter engineering, ConvNets can autonomously learn these filters and characteristics through adequate training.

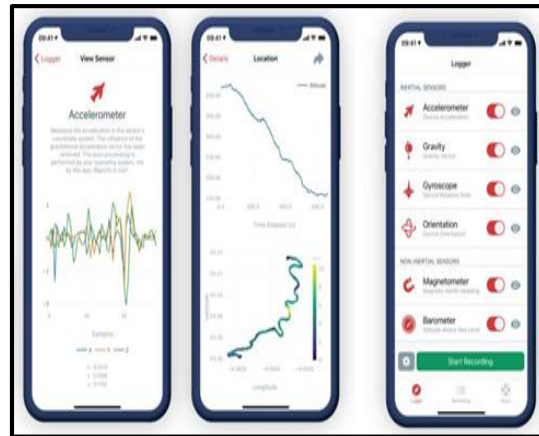
Figure 6 Sensor Logger Application

The accelerometer sensor used by the Sensor Logger program measures the acceleration of gravity along the x, y, and z-axes. The z-axis corresponds with vertical motion in this situation, which is often brought on by bumping into a pothole or experiencing a shift in slope. The y-axis is connected to the vehicle's turning left or right, while the x-axis represents the vehicle's acceleration and braking.

The Sensor Logger app is a free and versatile tool, which records information from various smartphone sensors, including the accelerometer, gyroscope, and GPS. An easy-to-use interface allows users to adjust the sensor selection and sampling frequency. Figure 6 shows the screen shot of sensor logger application. The app allows users to view interactive plots or export data in CSV or JSON formats. For this study, the app was used to gather data on road surface acceleration, which was then examined in Excel and graphed to show the location and severity of the distress. The graphs were used to identify major difficulties like potholes and bumps as different speeds were tested. Significant distress was indicated by peaks in the graph. Data on the minimum and average vibration helped evaluate pavement deterioration.

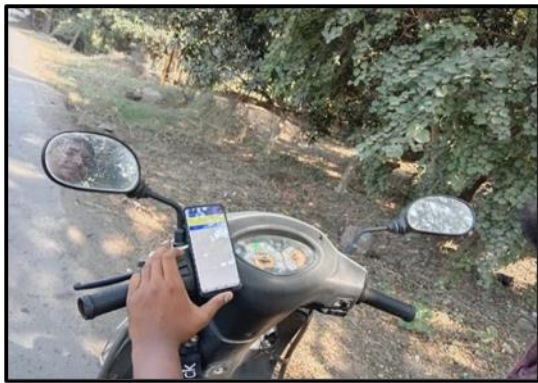
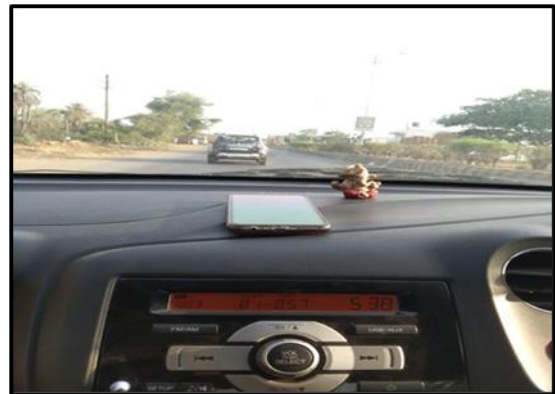
Figure 9 Mobile Mounted on Bike and Car

To record vibration data, a smartphone of the 'Activa 6G' model was safely mounted on the top side of a bike as shown in figure 9. This information was gathered in February 2022 during the daytime at various speeds of 15 km/h, 20 km/h, and 25 km/h. As the vehicle moved, the application measured the actual length of the road segment. Five monitoring iterations were carried out for each travel speed along the street segment in order to improve vibration measurements, with the goal of determining the most precise number of iterations.

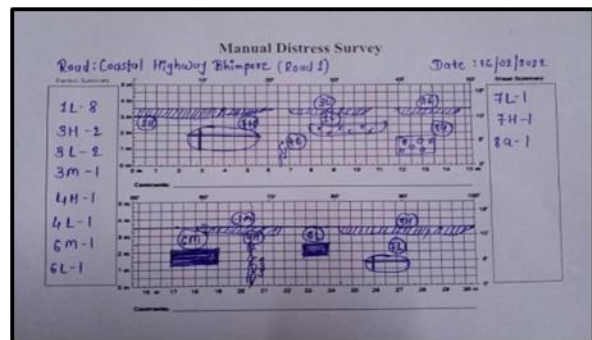
Figure 10 Manual Measurement of distress

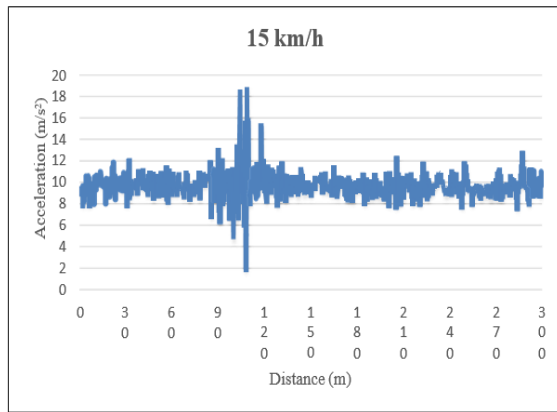
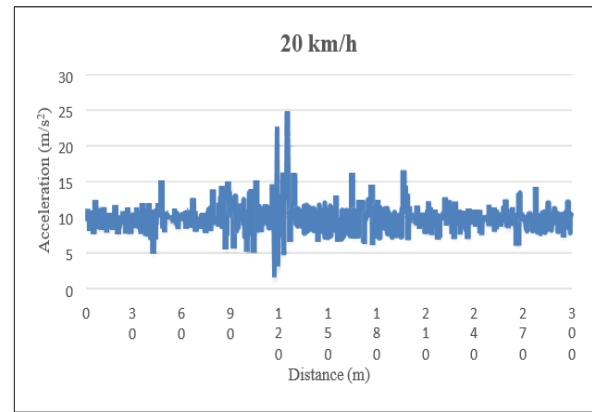
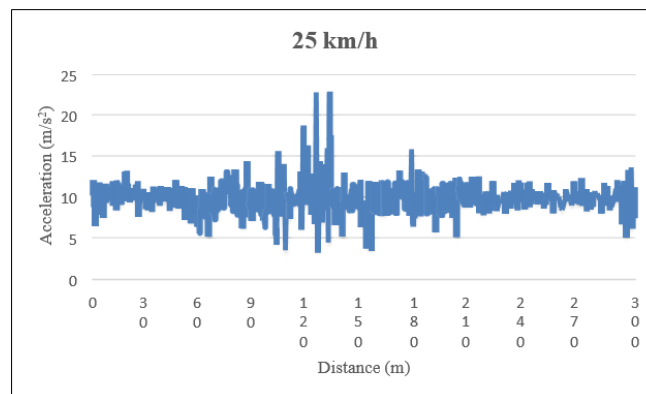
Magnitude of pavement vibration data at speed of 15 km/h

Magnitude of pavement vibration data at speed of 20 km/h

Magnitude of pavement vibration data at speed of 25 km/h

Figure 12 Analysis of data collected using BIKE at different Speed

The graph shows how much the pavement vibrates when a 'bike' is moving at different speeds figure 12. The slow bike movement causes slight vibration changes at 15 km/h. Average vibrations ranged from 1.873 m/s² to 18.874 m/s², respectively. The highest and lowest average vibrations were 26.228 m/s² and 1.683 m/s² at 20 km/h, respectively. These values were 30.998 m/s² and 3.551 m/s² at 25 km/h.

Vibration damages pavement and increases with speed. Smartphone sensors exhibit high sensitivity to vibrations from moving traffic. Higher bike speeds increase the precision of vibration data, revealing serious pavement damage like potholes. Lower vibration values, however, imply that maintenance is not immediately required.

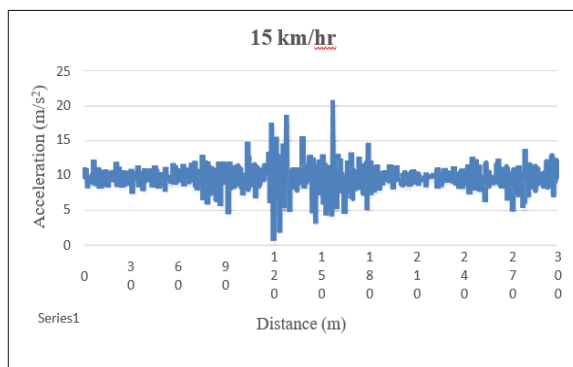
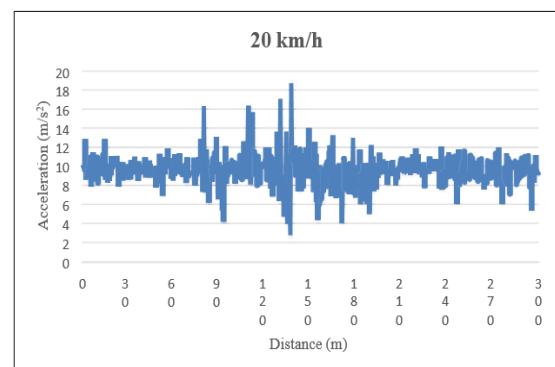
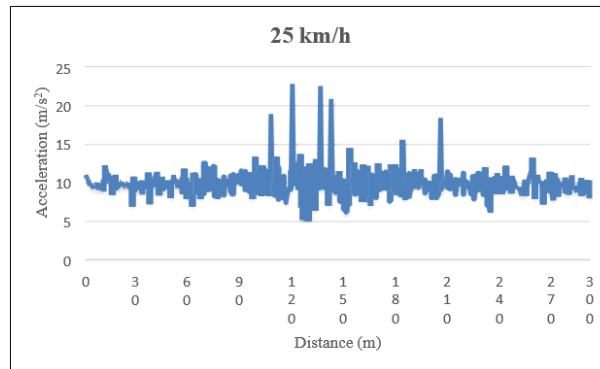
Magnitude of pavement vibration data at speed of 15 km/h

Magnitude of pavement vibration data at speed of 20 km/h

Magnitude of pavement vibration data at speed of 25 km/h

Figure 13 Analysis of data collected using CAR at different Speed

Significant variations can be seen in the figures, which show pavement vibration data obtained from the ‘car’ at various speeds figure 13. The vibration levels varied from about 0.904 m/s² at 15 km/h to about 20.81 m/s² at a speed that reflected the car's slow motion. The highest and lowest values were 25.51 m/s² and 2.15 m/s², respectively, at 20 km/h. The maximum vibration data at 25 km/h was around 26.84 m/s², and the minimum was about 0.567 m/s².

Due to the smartphone sensor's increased sensitivity, it is notable that speeds of 15 km/h and 25 km/h show a significant variation between maximum and minimum vibration data. The results highlight a direct correlation between pavement vibration measurements and travel speeds, with higher speeds causing more pavement vibration because of amplified vibrations in the vehicle chassis.

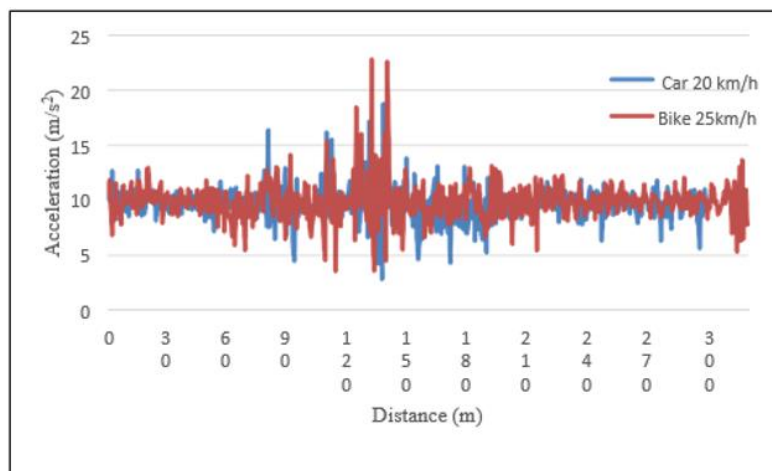
Figure 14 Comparison of data collected using Bike and Car

Following manual surveying, it is evident that pavement vibration data collected by bike is most accurate at 25 km/h, while data collected by car is most accurate at 20 km/h. As a result, it is possible to conclude that the pavement vibration data obtained via the smartphone application in both vehicle tests is of sufficient accuracy. Figure 14 shows comparison of data collected using bike and car.

The study reveals that the highest acceleration vibration is observed between 90m and 150m, indicating significant road distress, likely major types like potholes and alligator cracks, requiring immediate maintenance. Less fluctuation is observed from 150m to 180m, suggesting minor distress like patches and cracks. The method provides accurate distress location but doesn't precisely identify distress types. The experiment highlights the suitability and accuracy of both bikes and cars for pavement monitoring, and the significant influence of travel speed on pavement vibration data precision.

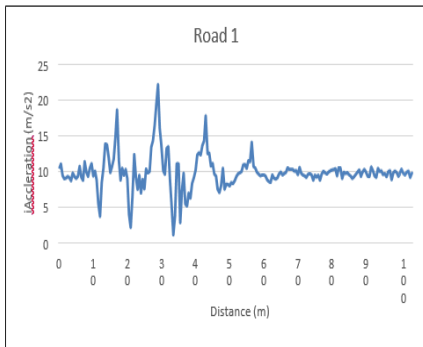
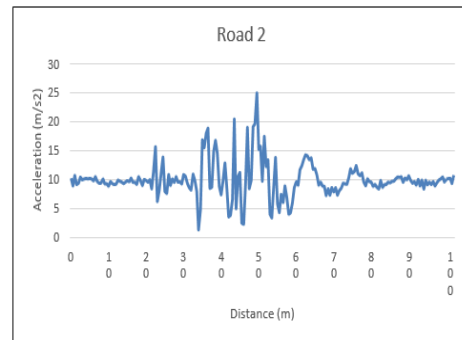
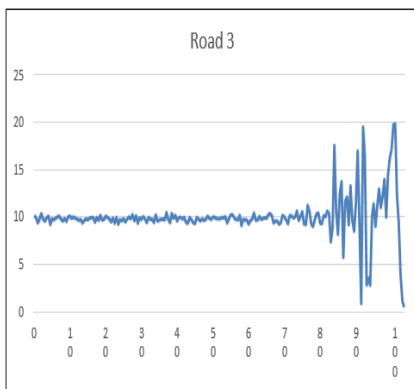
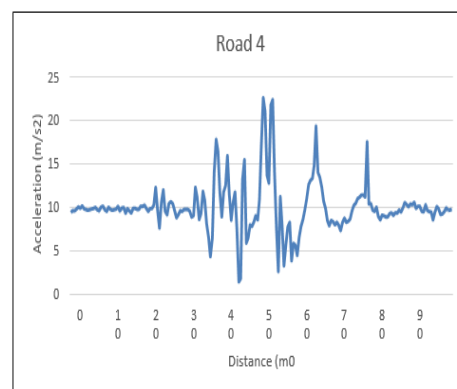
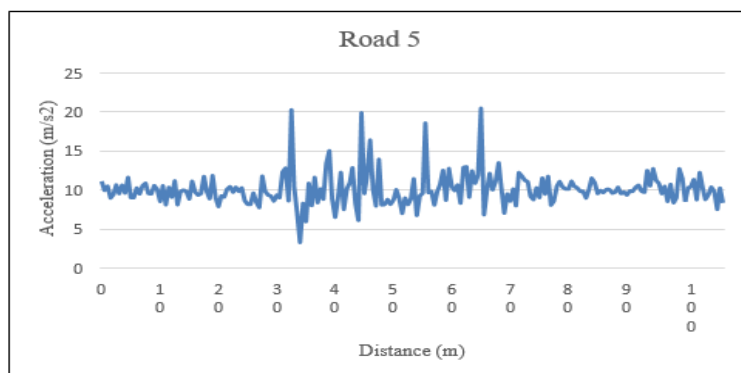
Magnitude of pavement vibration data of road 1

Magnitude of pavement vibration data of road 2

Magnitude of pavement vibration data of road 3

Magnitude of pavement vibration data of road 4

Magnitude of pavement vibration data of road 5

Figure 15 Magnitude of pavement vibration on all the roads

We chose five 100m road stretches to compare vibration and vision-based methods. On all five roads, the Sensor Logger application was used to collect acceleration data from the road surface. This acceleration data was then meticulously analysed in Excel. The number of potholes was determined using the resulting Excel-generated graph. Manual distress surveys were used to validate the accuracy of this analysis. Figure 15 shows Magnitude of pavement vibration on all the roads
