Identifying and analyzing disaster mitigation strategies for sports hall

Franky R Tombokan, Tampanatu PF Sompie *, Mario ML Moningka, Sudenroy Mentang and Novriana A Pangemanan

World Journal of Advanced Engineering Technology and Sciences, 2024, 12(02), 865–871

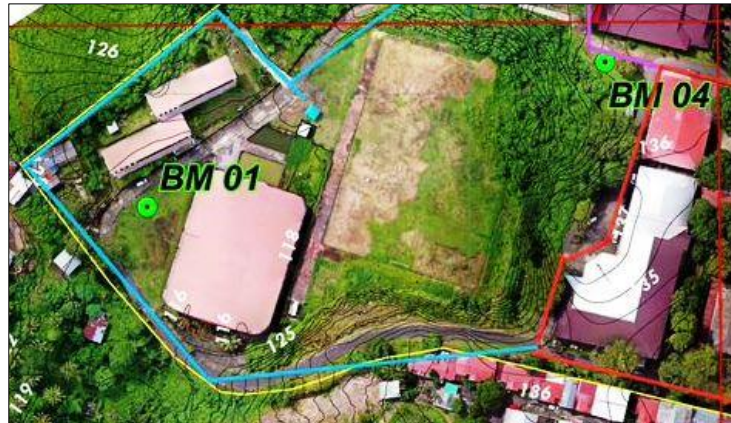
Figure 2 Study area

Mapping with drones produces highly detailed 2D and 3D topographic maps, providing a comprehensive view of the landscape around the Manado State Polytechnic Sports Hall. These maps reveal land contours, vegetation, and other structures surrounding the Sports Hall. The mapping results indicate that the Sports Hall is situated in a relatively low-lying area compared to its surroundings, which increases the potential risk of flooding, especially during the rainy season when rainfall is heavy.

The 3D visualizations highlight that some areas around the Sports Hall are relatively flat, which could lead to prolonged water stagnation if an effective drainage system is not in place. Additionally, the mapping reveals that several points around the Sports Hall have steep slopes, which could channel rainwater directly toward the building, further heightening the risk of flooding. To mitigate these risks, improvements to the existing drainage system are necessary

- Drainage system improvement and enhancement; Given the high risk of flooding, the existing drainage system should be redesigned to manage rainwater flow more effectively. The capacity of drainage channels around the Sports Hall should be increased to ensure that rainwater is quickly drained and does not pool around the building.

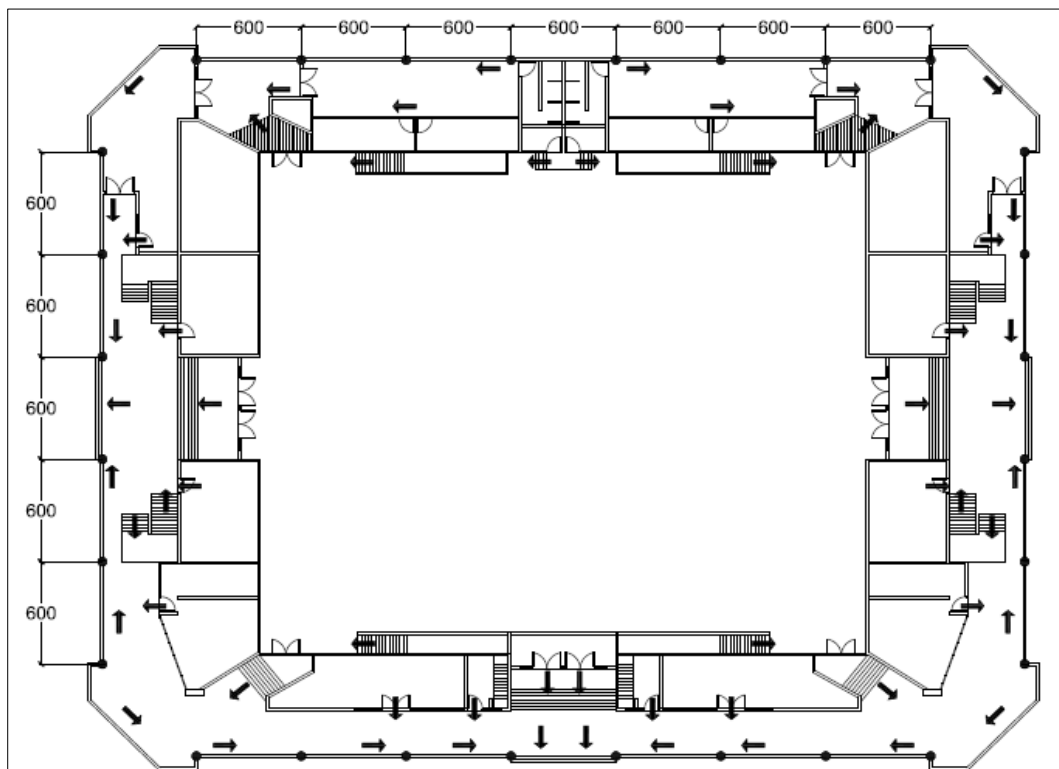
Figure 5 Evacuation routes

The resulting layout highlights several critical areas within the Sports Hall that require improvement. The current evacuation route is suboptimal, and the lack of clear evacuation signs could impede the evacuation process during an emergency. It is essential to redesign the evacuation route and install clearer, more visible evacuation signs.

- Optimization of evacuation routes; The existing evacuation routes should be redesigned to ensure they are efficient and easily accessible in an emergency. The width of these routes must meet the minimum standards to accommodate a large number of users. Additionally, evacuation routes should be kept free of any obstacles that could impede swift movement.

- Installation of evacuation signs; Clear and easily recognizable evacuation signs should be installed throughout the Sports Hall. These signs must be visible from various angles, particularly in areas with low visibility. Emergency lights that automatically activate during a power outage should also be installed along the evacuation routes.
