Microstructural Evolution in AA7055 Aluminium Alloy Under Dynamic Shock Loading

World Journal of Advanced Engineering Technology and Sciences, 2025, 17(01), 115-135

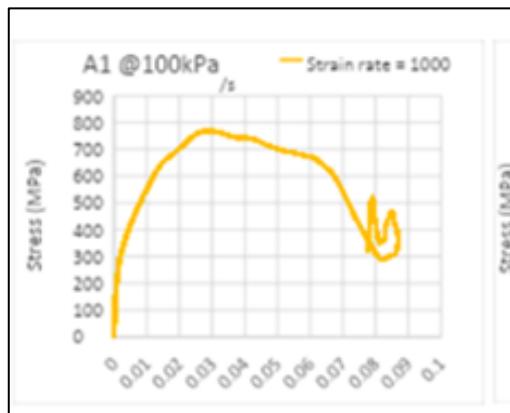
**Figure 1** AA7055-T7751 Aluminium Alloy at 100kPa

From the Engineering Stress strain curve above, at impact pressure of 100kPa, the maximum Stress obtained is 768.20MPa and maximum strain is 0.077 with a strain rate of 1000/s (Figure 1). At an impact pressure of 120kPa, maximum stress is 718.05MPa and maximum strain is 0.096 with a strain rate of 1160/s (Figure 2). For 140kPa pressure, maximum stress is 692.31MPa and maximum strain is 0.103 with a strain rate of 1280/s (Figure 3). At impact pressure of 160kPa, maximum stress is 822.19MPa at maximum strain of 0.115 with a strain rate of 1400/s. (Figure 4)

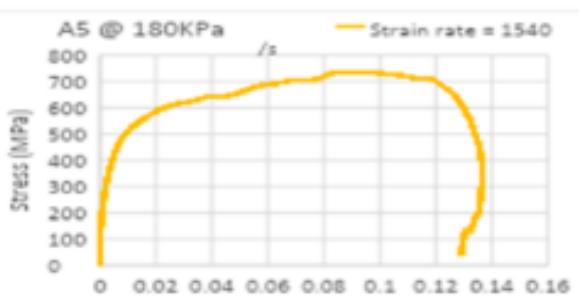
**Figure 5** AA7055-T7751 Aluminium Alloy at 180kPa

For an impact pressure of 180kPa, maximum stress is 735.86MPa and maximum strain is 0.128 with a strain rate of 1540/s (Figure 5). At an impact pressure of 200kPa, maximum stress is 768.59MPa and maximum strain is 0.14 at a strain rate of 1640/s. (Figure 6)

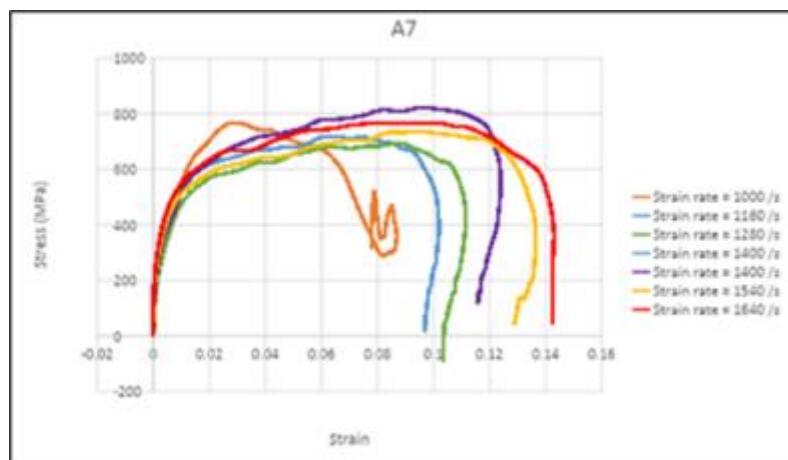
Figure 7 A co-plot of AA7055-T7751 of varying pressure of 100-200kPa.

Based on Table 2 above, we can make a co-plot of the Stress - Strain curve of all six impact pressures

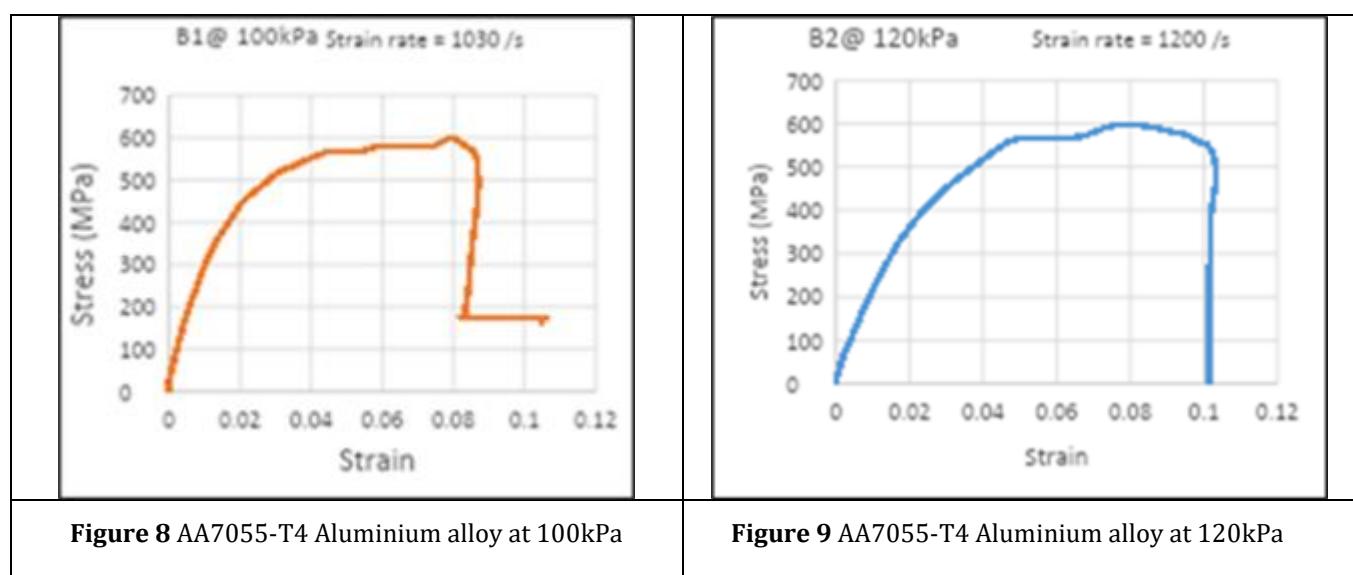
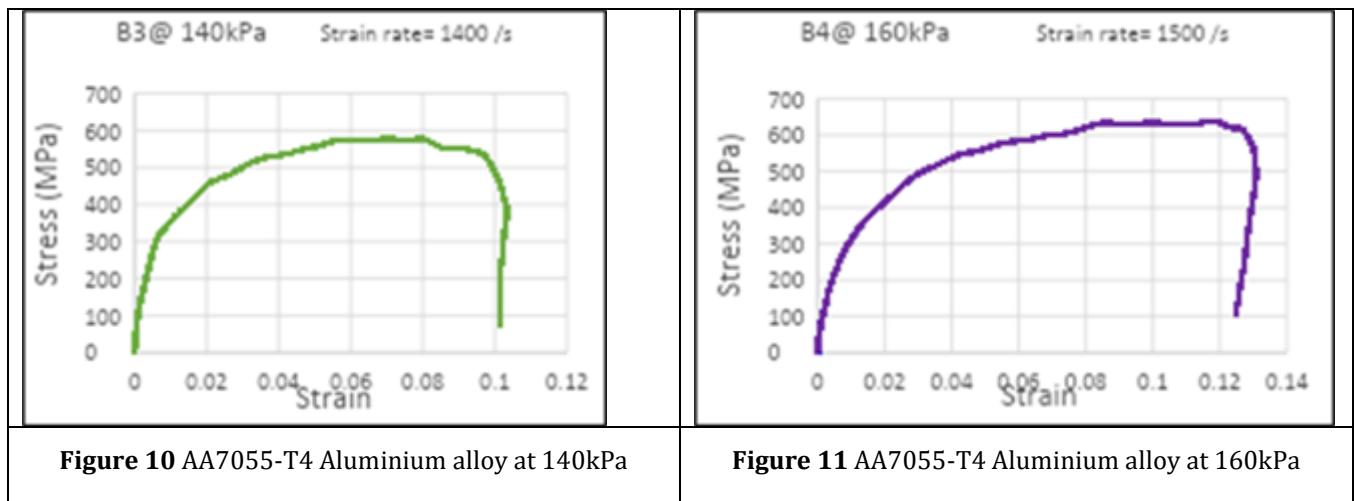
At an impact pressure of 100kPa, maximum stress is obtained as 598.64MPa and maximum strain is 0.104 with a strain rate of 1030/s (Figure 8). Also, for 120kPa, maximum stress is 597.72MPa and a maximum strain rate of 0.101 with a strain rate of 1200/s (Figure 9). At an impact pressure of 140kPa (Figure 10), maximum stress is 577.49MPa and maximum strain is 0.101 with a strain rate of 1400/s. For an impact pressure of 160kPa, maximum stress is 639.79MPa

and maximum strain is 0.125 with a strain rate of 1500/s (Figure 11). At pressure of 180kPa, maximum stress is 625.56MPa and maximum strain is 0.162. (Figure 12)

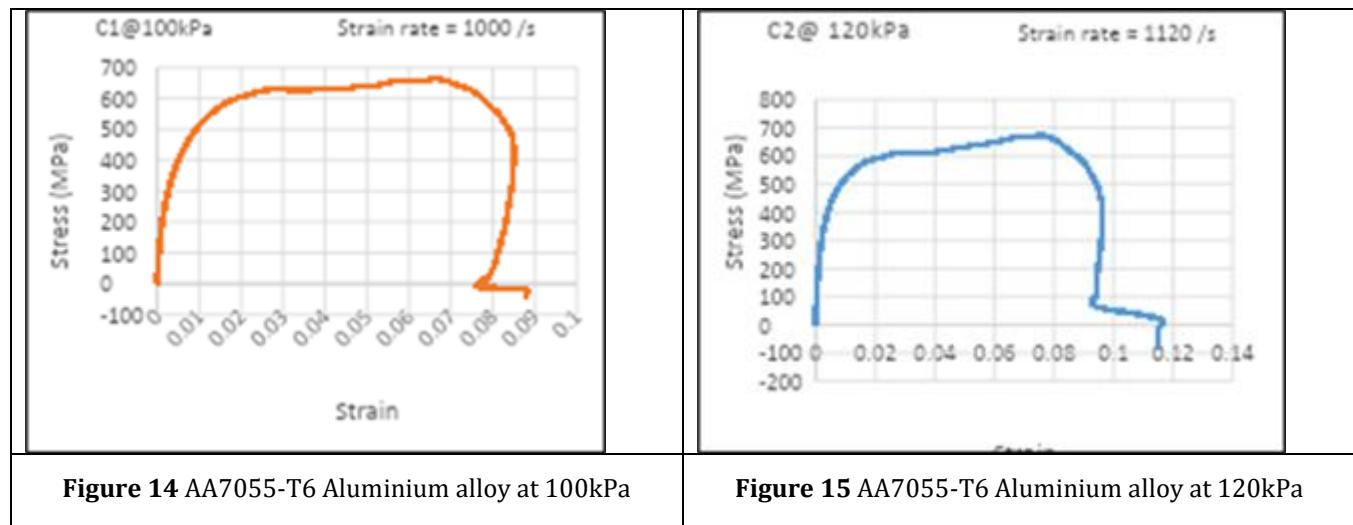
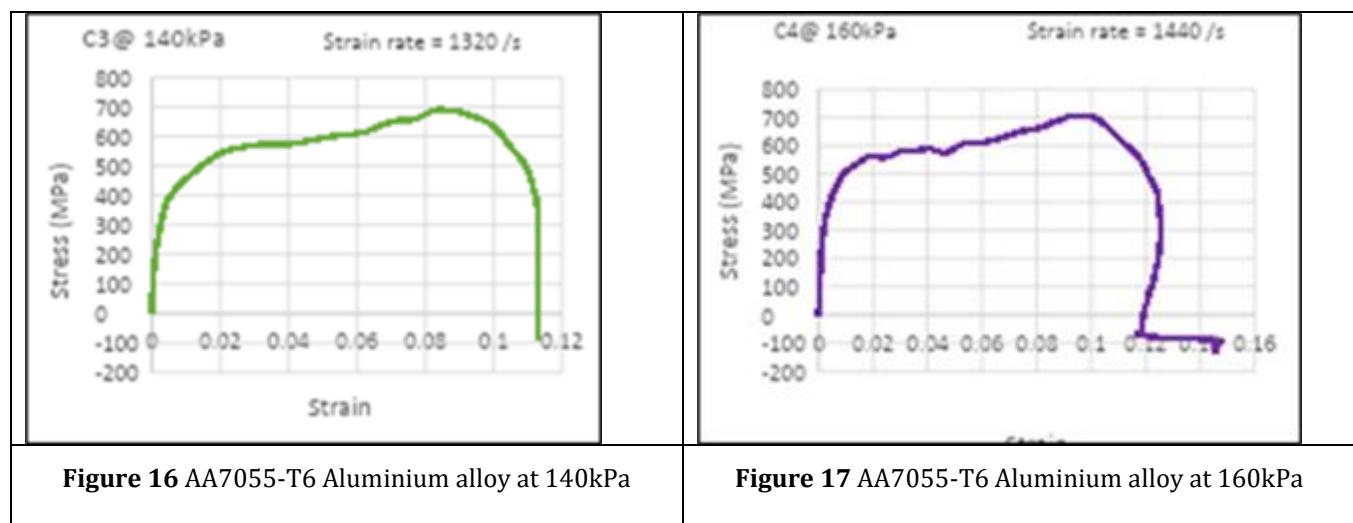
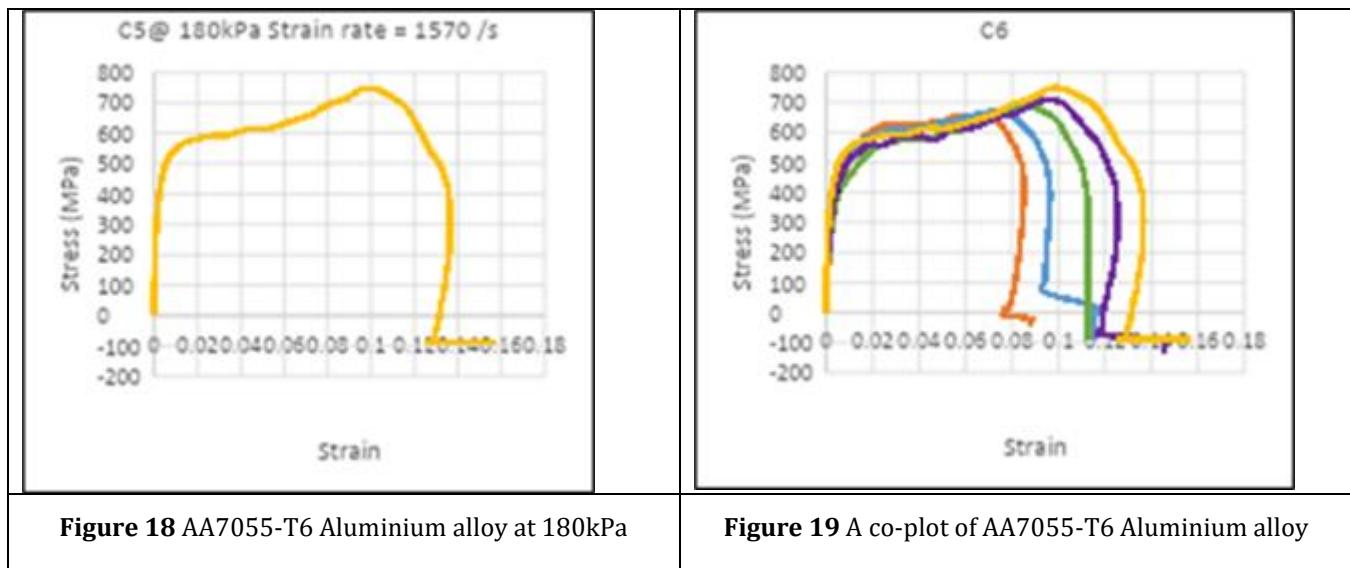
In Figure 14; at an impact pressure of 100kPa, the maximum strength obtained is 662.11MPa and maximum strain is 0.076 with a strain rate of 1000/s. At an impact pressure of 120kPa, maximum strength obtained is 671.87MPa and maximum strain is 0.115 with a strain rate of 1120/s (Figure 15) At an impact pressure of 140kPa, the maximum stress obtained is 690.36MPa and maximum strain is 0.112 with a strain rate of 1320/s (Figure 16). At impact pressure of 160kPa, maximum strength is 707.48MPa and a maximum strain of 0.118 with a strain rate of 1440/s (Figure 17).

At an impact pressure of 180kPa, maximum strength obtained is 748.46MPa and a maximum strain rate of 0.131 with a strain rate of 1570/s (Figure 18). A co-plot generated in Figure 19 above.

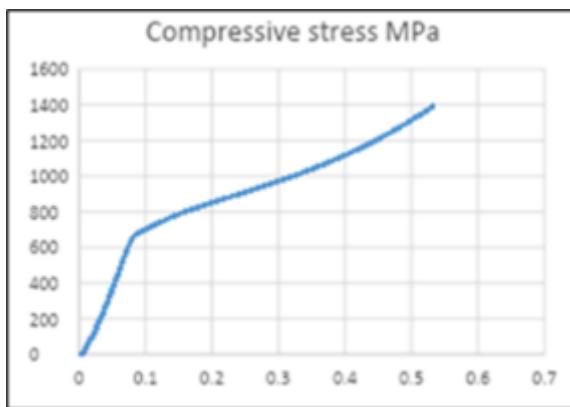
Figure 20 As received AA7055-T7751 (01)

From Figure 20 the ultimate tensile strength is obtained as 1391.86MPa and strain at failure is 0.532

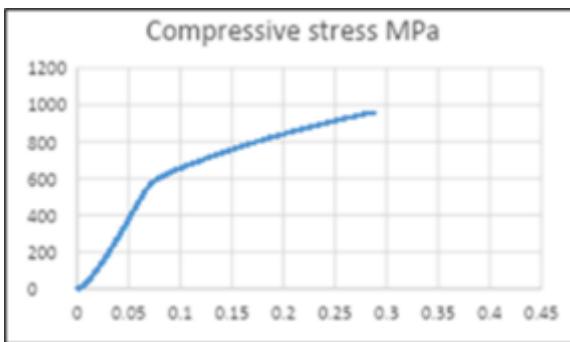
Figure 21 AA7055-T6 Temper Aluminium alloy (01)

For the T6 temper alloy, UTS obtained was 957.06MPa and strain at failure is 0.287 as shown in Figure 21

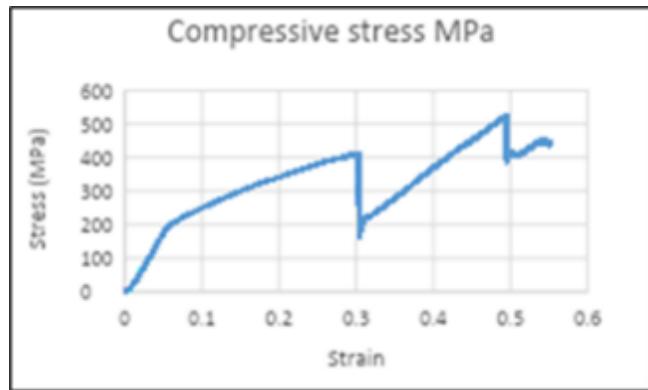
Figure 22 AA7055-T4 temper aluminium alloy (01)

In Figure above (Figure 22), the applied load for compression used is 100KN at a strain rate of $3.2 \times 10^{-3}/\text{s}$. The stress-strain curve obtained has an ultimate tensile strength of 410.92MPa with a necking region and on further application of the load the UTS obtained was 524.89MPa with strain at failure obtained as 0.494.

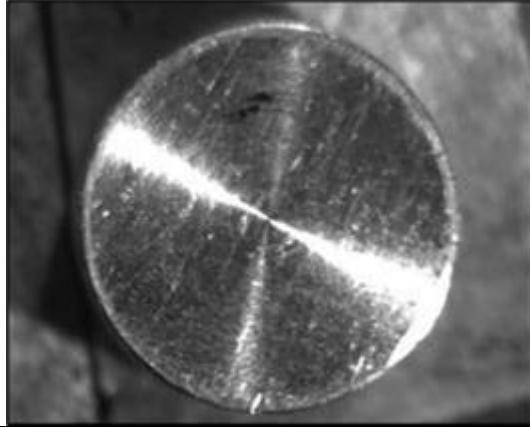
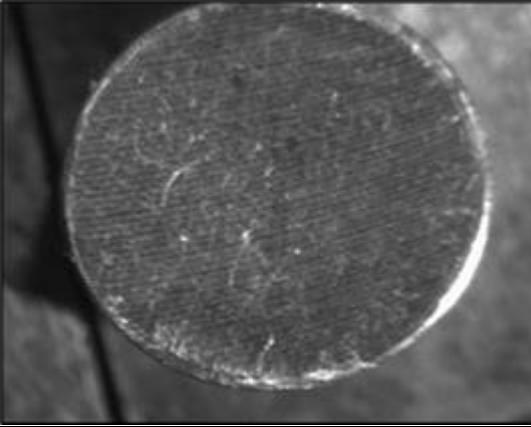
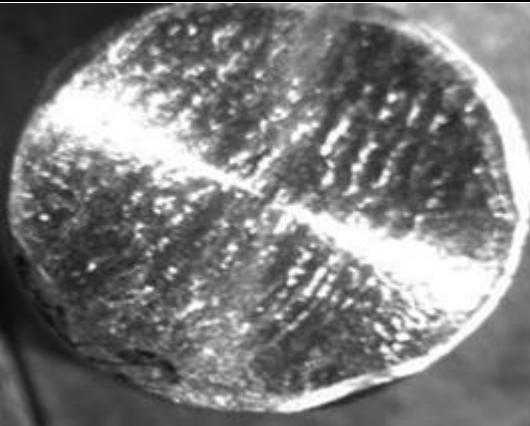
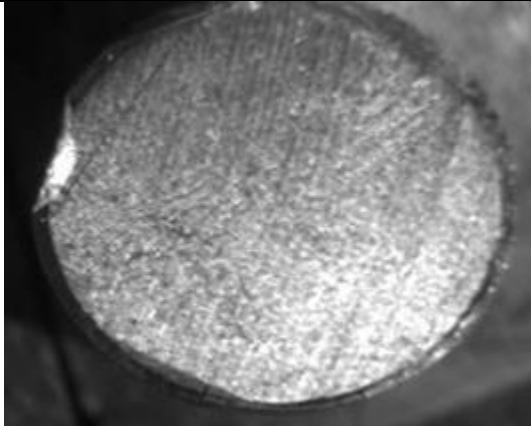
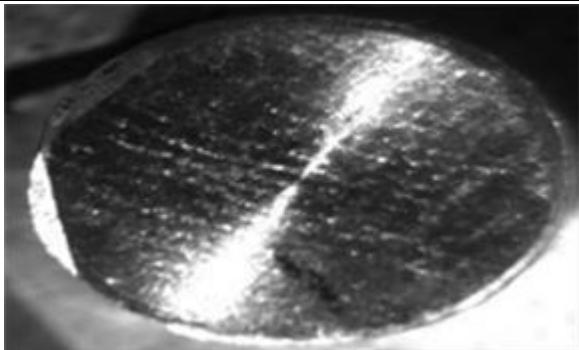
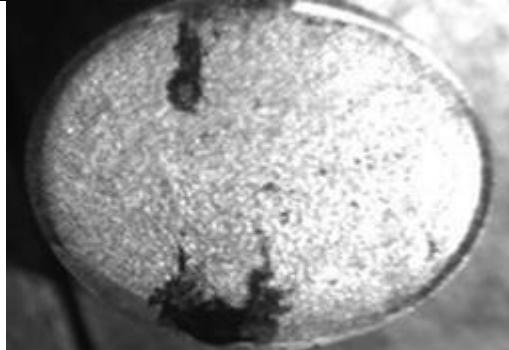
Figure 23 Incident impact showing formation of failure at 100KPa	Figure 24 Reflected fracture surface showing striations at 100KPa

Figure 25 Incident impact showing formation of fracture at 120KPa	Figure 26 Reflected fracture surface showing striations at 120KPa

Figure 27 Incident impact showing formation of fracture at 140KPa

Figure 28 Reflected fracture surface showing inclusions and striations

In Figure 23 - Figure 28, there is an impact showing formation of fracture at 100KPa as well as striations in the reflected fracture surface. At 120KPa, incident impact showing formation of fracture becomes more visible and reflected fracture surface showing striations. With impact pressure of 140KPa, the formation of fracture is shown while reflected fracture surface indicates inclusions and striations.

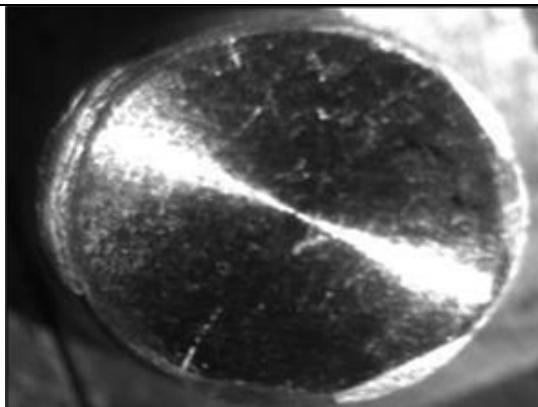
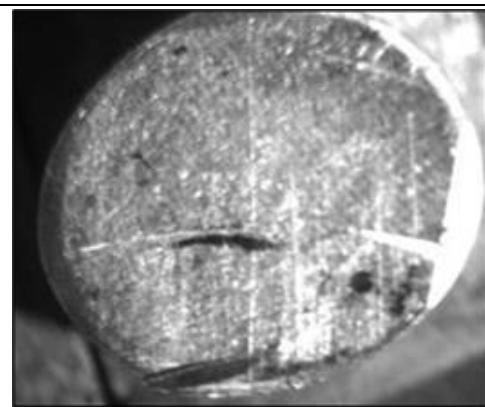
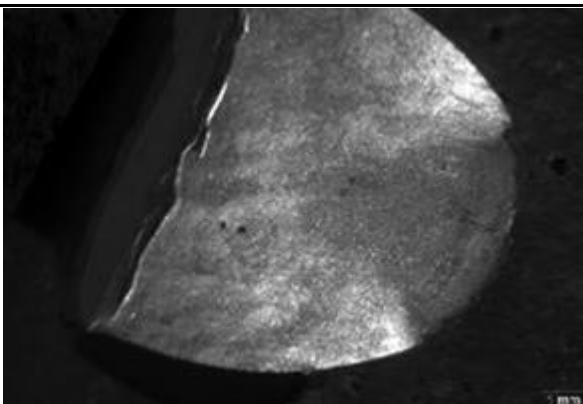
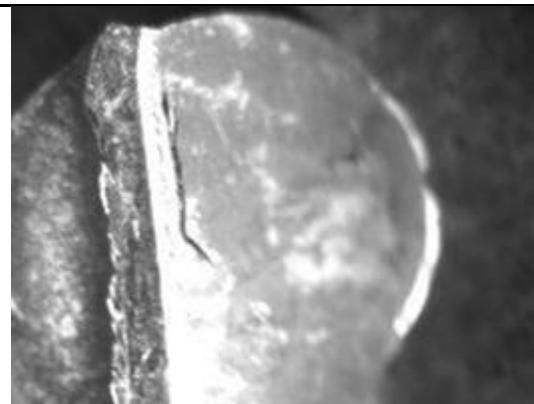
In Figure 29 - Figure 32, at impact pressure of 160KPa, there is formation of cracks and the reflected surface shows cracks and inclusions as in Figure 30. At an impact pressure of 200KPa, there is a cup and cone fracture showing failure of the alloy as seen in Figure 31 and in Figure 32 there is also a cup and cone fracture showing failure of the alloy AA7055.

Figure 29 Incident impact showing formation of cracks at 160KPa

Figure 30 Reflected surface showing cracks and inclusions at 160KPa

Figure 31 Cup and Cone fracture showing failure of the alloy at 200KPa

Figure 32 Cup and cone failure of AA7055 alloy at 200KPa

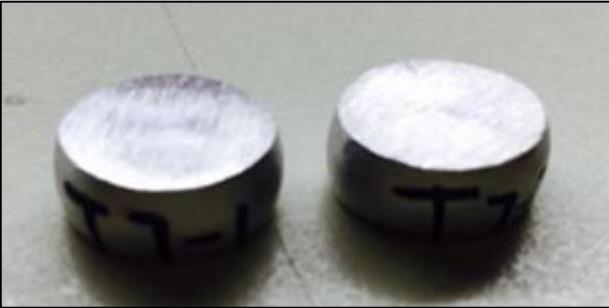
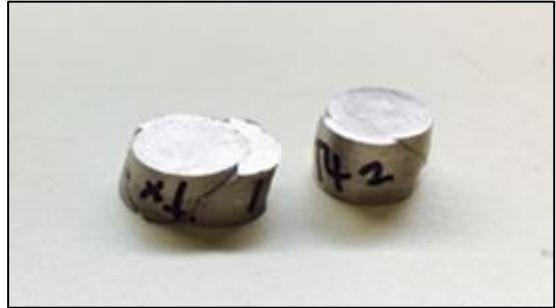
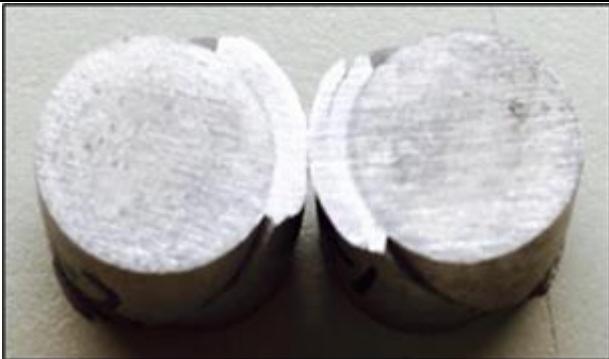
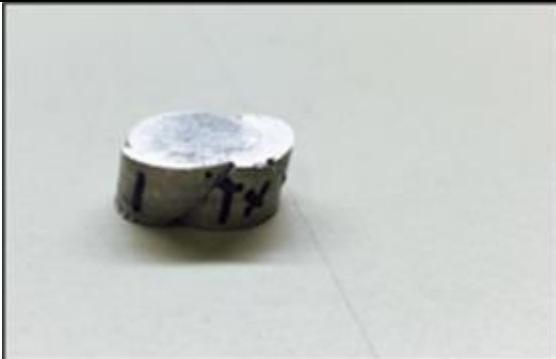
Figure 33 Reduction in height of AA7055-T7751 Aluminium alloy	Figure 34 Failure of AA7055-T4 Aluminium alloy (side view)

Figure 35 Crack failure of AA7055-T6 Aluminium alloy	Figure 36 Failure of AA7055-T4 Aluminium alloy (Front view)

In Figure 33 – 36 above, pictorial view of AA7055 aluminium alloy at temper conditions of T7751, T6, and T4 shows reduction in height from the original dimensions as well as failure of the alloy (cracks) when subjected to a load of 100KN at a cross head speed of 2mm/min and strain rate of 3.2×10^{-3} . Table 1.3 gives the reduction in height obtained.

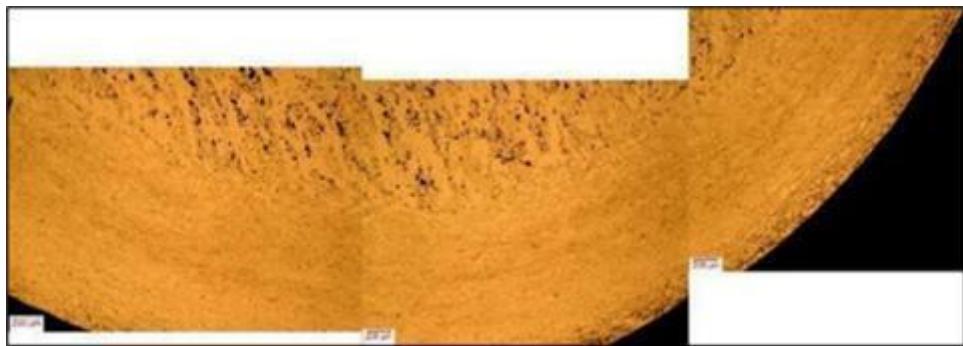
The AA7055-T7751 Aluminium alloy was impacted showing the adiabatic shear band below at a Magnification of X50. The deformed band can be seen to progress across the circumference of the alloy as shown in Figure 37.

Figure 37 Shear band formed in the as-received AA7055-T7751 alloy after impact with a magnification of X50

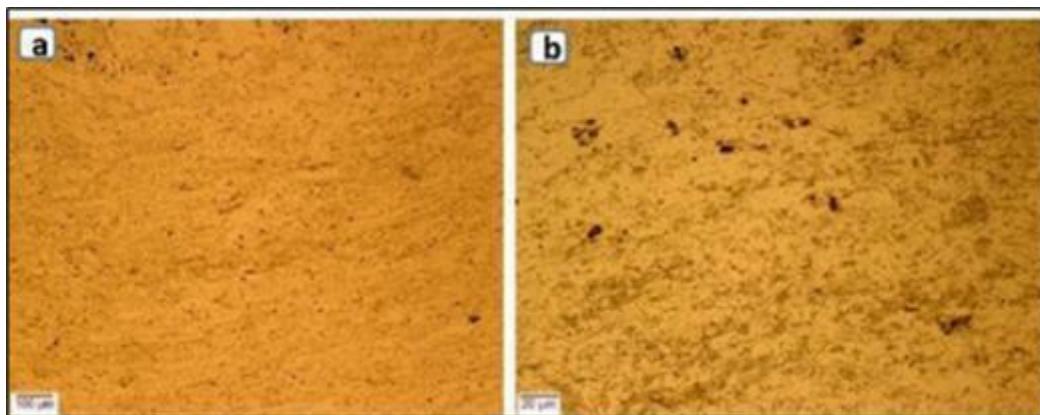
In Figure 37(a) there are elements of trace particles that can be considered as second phase particles with a magnification of X50; with clearly visible grain boundaries shown inside the deformed band of the adiabatic shear band formed by the impact of AA7055-T7751 alloy at a higher magnification of X500. (Figure 37b)

Figure 37 (a) Inside band of shear band formed at a magnification of X100 (b) Inside band of shear band at magnification of X500

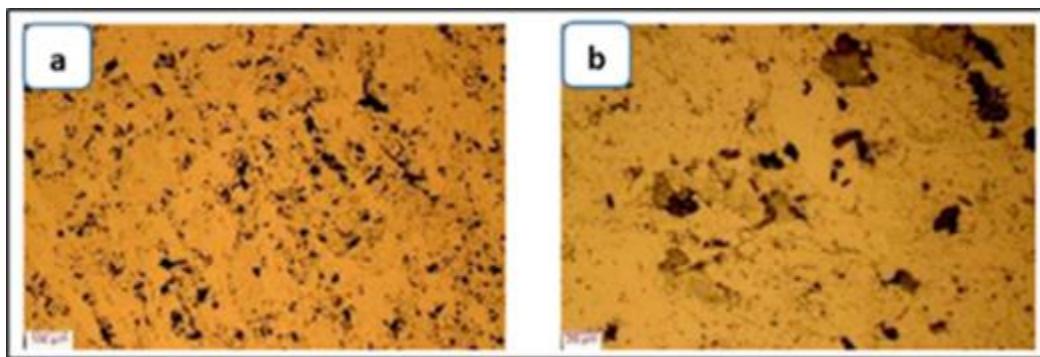
In Figure 38a the microstructure can be viewed to occur outside the deformed shear band at a magnification of X100. At a higher magnification of X500, (Figure 38b) the second phase particles are seen as well as the grain boundaries.

Figure 38 (a) outside band of AA7055-T7751 at magnification of X100; (b) a higher magnification at X500

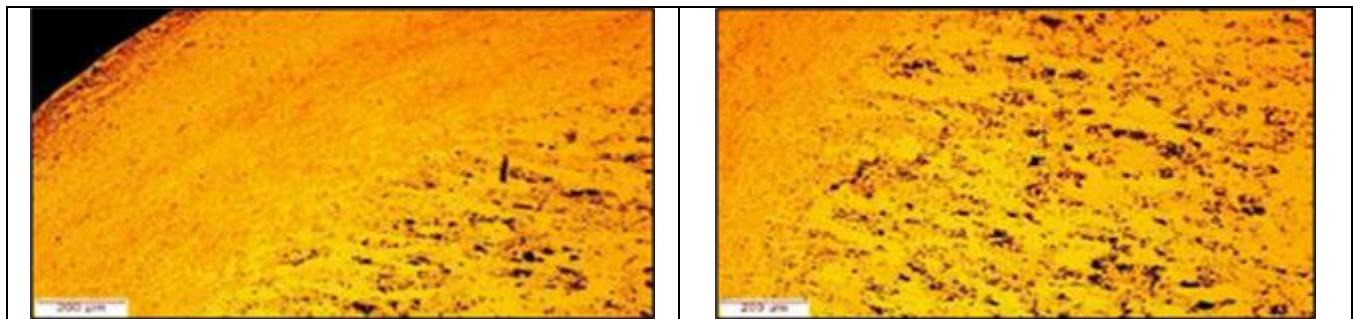
In Figure 39 Adiabatic shear band formed at the circumference of the alloy indicating deformation of the alloy. Irregular coarse grains are formed outside the band in Figure 40a and a higher magnification reveals the grains in Figure 40b.

Figure 39 Adiabatic shear band formed along the circumference of the alloy at X50

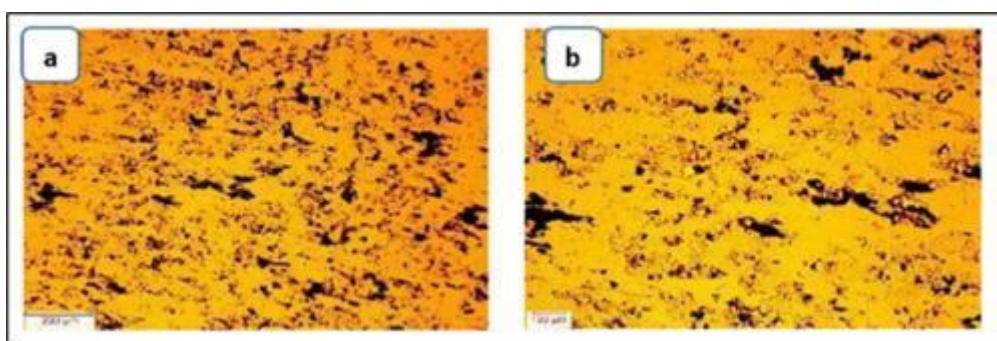
Figure 40 (a) Images at X50 of compressed AA7055-T7751 (b) Outside band of AA7055-T7751 at magnification of X100

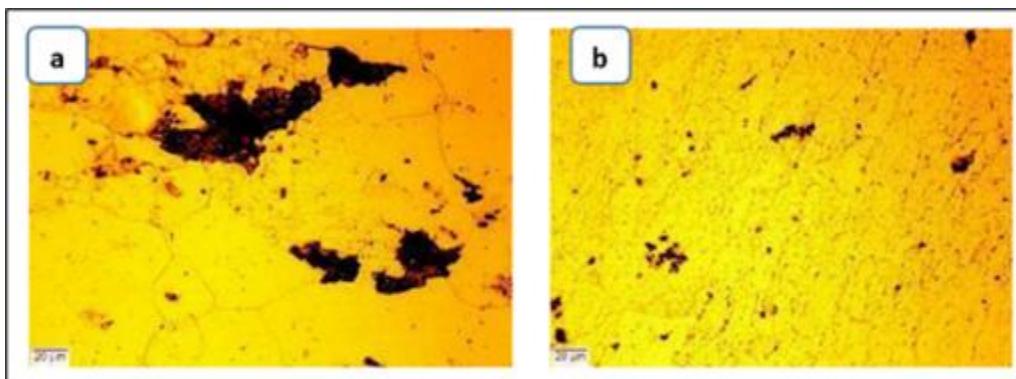
Figure 41 (a) outside band of AA7055-T7751 at X500 (b) Inside band of AA7055-T7751 at magnification of X500

In Figure 41(a) at a higher magnification, we can clearly see large grain boundaries and presence of second phase particles. In Figure 41(b) a fine uniformly dispersed and elongated grain of alloy is seen as well as traces of second phase particles.

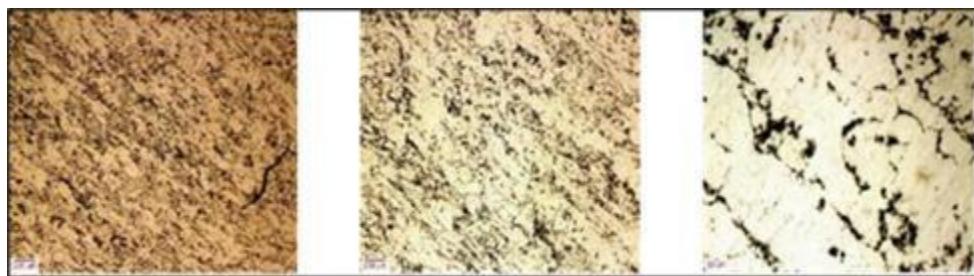
Figure 42 Microstructure of AA7055-T6 aluminium alloy at Magnification of X50, X100, X500 when impacted at 100kPa (C1)

In Figure 42 above, no presence of adiabatic shear band formed in the microstructure. However,

The alloy was subjected to an impact pressure of 100kPa with a momentum of 33kg.m/s. The alloy can be said to be finely dispersed with uniform distribution of second phase particles. At higher magnification of X500, the grain boundaries are clearly visible and the fine structure shown.

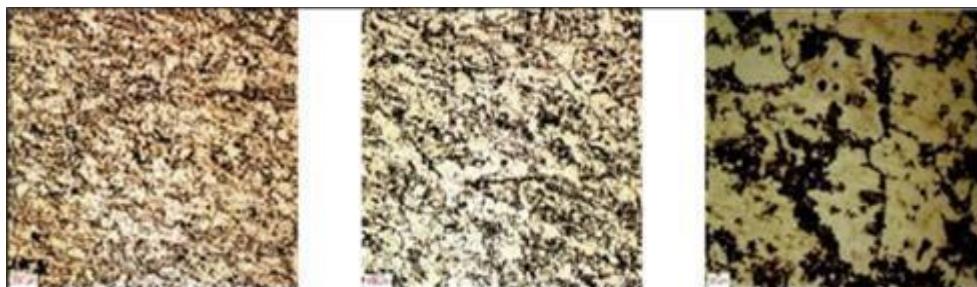
In Figure 43, a closely packed microstructure is shown below with no presence of adiabatic shear band formed at the centre. This alloy was subjected to impact pressure of 120kPa and momentum of 39.02kg.m/s. However, along the circumference of this particular alloy, Figure 44, there are visible traces of adiabatic shear band formed as a result of the alloy.

Figure 43 Microstructure of AA7055-T6 aluminium alloy at Magnification of X50, X100, X500 when impacted at 120kPa (C2)

Deformation of T6 tempered alloy is noticeable along the circumference of the alloy as shown in Figure 43 at a magnification of X50. The failure of this material is due to the presence of cracks formed at the tip.

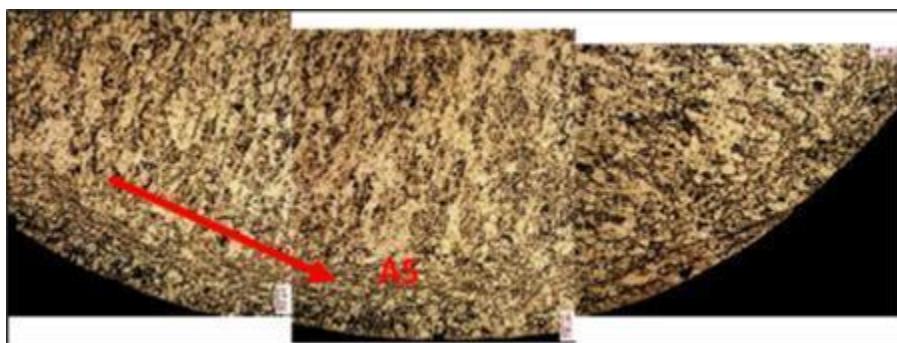
Figure 44 Deformation of AA7055-T6 alloy along the circumference at impact pressure of 120kPa (C2) at magnification of X50

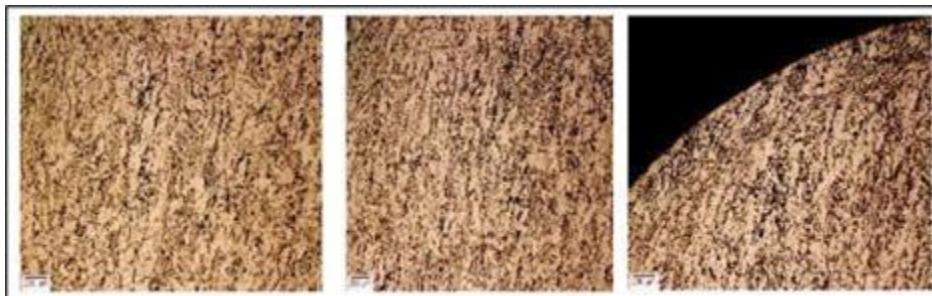
Also, at an impact pressure of 140kPa with momentum of 45.01kg.m/s, slight deformation can be found at the circumference of the alloy. Hence, the higher the impact pressure applied the more the material deforms. As can be seen at the third section of Figure 45.

Figure 45 Microstructure of AA7055-T6 alloy at impact pressure of 140kPa (C3) at a magnification of X50

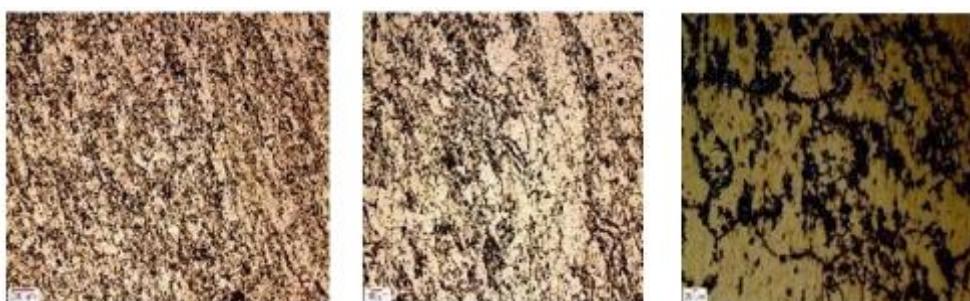
Figure 46 Microstructure of AA7055-T6 alloy at impact pressure of 160kPa (C4) at magnifications of X50, X100, X500

In Figure 46, the microstructure above shows closely packed grain structure at magnification of X50, X100 and X500. However, in Figure 47 an adiabatic shear band is formed along the circumference of the alloy showing deformed band from a pressure of 160kPa and momentum of 50.51kg.m/s.

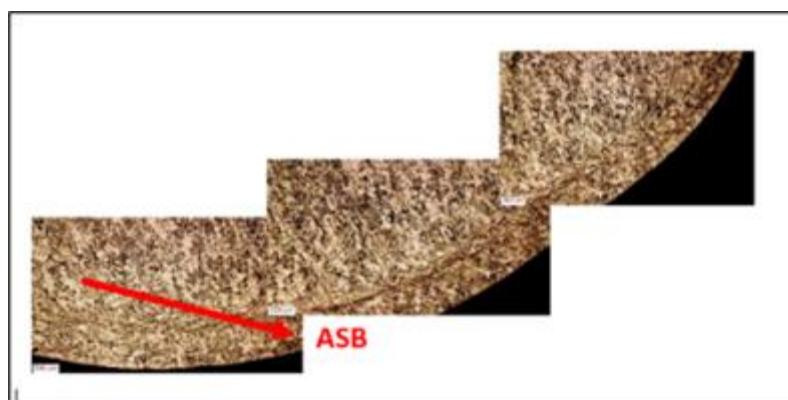
Figure 47 Deformed shear band formed along the circumference at an impact pressure of 160kPa (C4) at magnification of X50

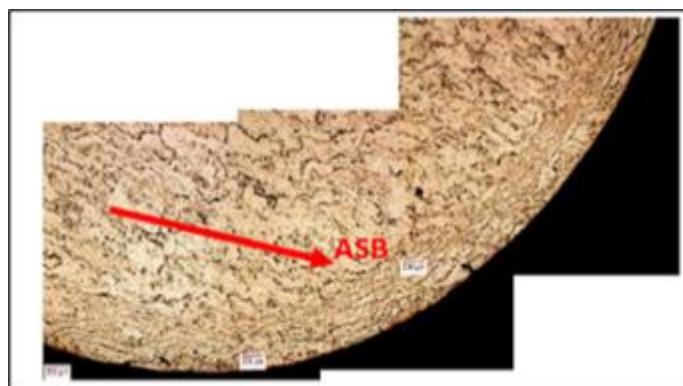
In Figure 487.12, the microstructure shows densely populated second phase particles and this region is outside the deformation area. In Figure 497.13, the region of deformation is clearly seen along the circumference of the alloy showing adiabatic shear band formed and presence of cracks along the edges caused by an impact pressure of 180kPa and momentum of 55.85kg.m/s.

Figure 49 Adiabatic shear band formed at the circumference of the alloy at an impact pressure of 180kPa (C5) and magnification of X50

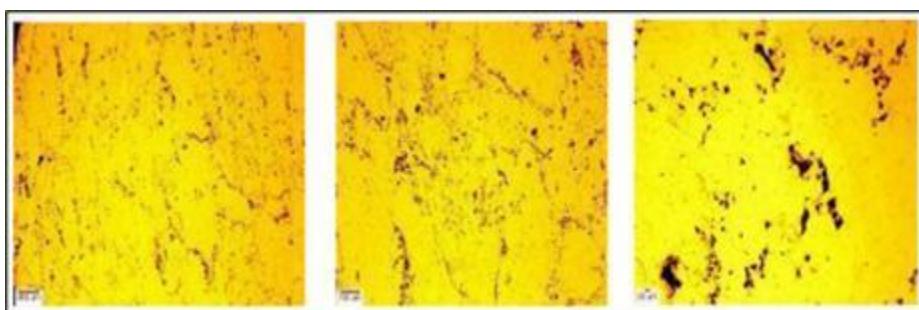
Figure 50 As received AA7055-T6 alloy at a magnification of X50, X100 and X500

The microstructure above Figure 50, shows fine grains with scarcely displaced microstructure at magnifications of X50, X100 and X500. The presence of large cracks can be seen in Figure 51. This is due to the applied load of 100kN. Also the deformed bands are seen at the circumference of the alloy and along the cracks.

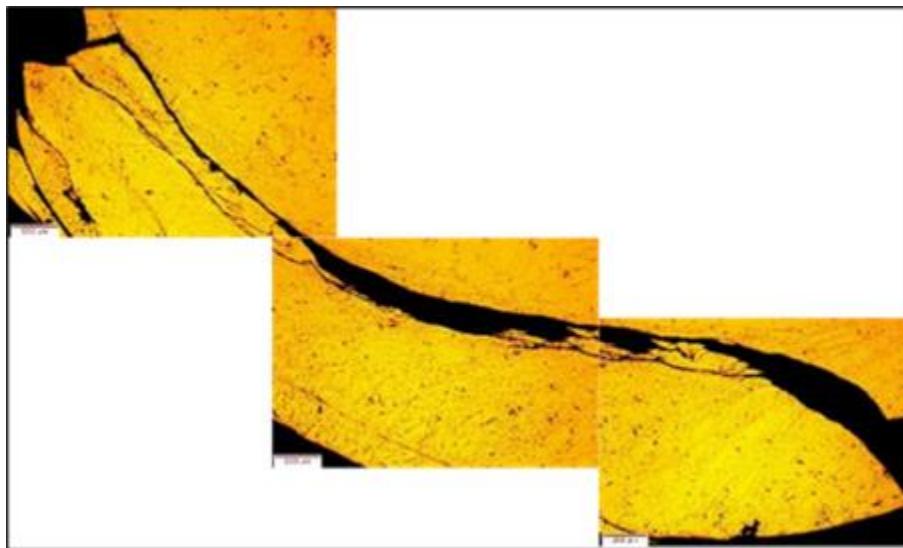
Figure 51 Compressed AA7055-T6 alloy at magnification of X50

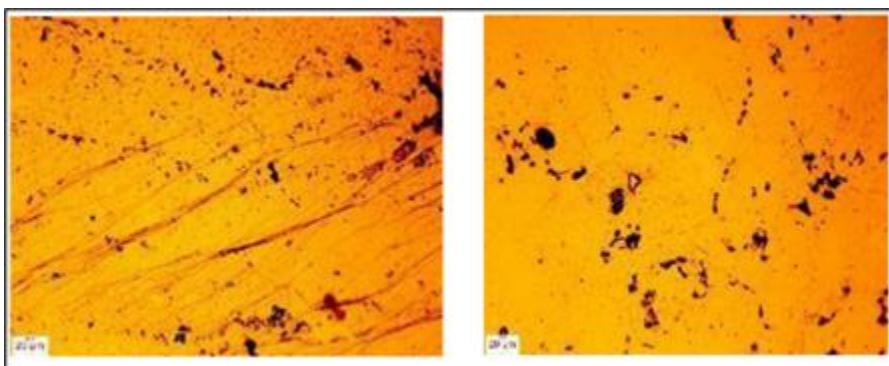
Figure 52 Microstructure of AA7055-T6 alloy at magnification of X500

In Figure 52 above, presence of metal flow can be seen in the microstructure in the first region and presence of scarcely populated second phase particles are shown in the second region.

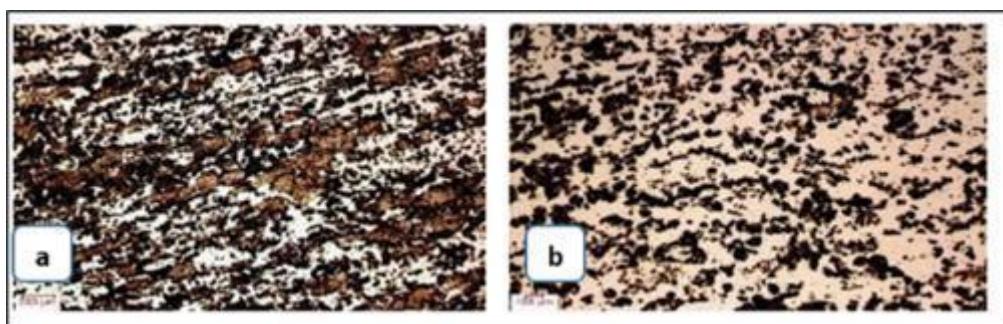
In the microstructure below (Figure 53), the presence of second phase particles are non-uniformly dispersed and account for a large fraction of the microstructure. There are no signs of adiabatic shear band formed at an impact pressure of 100kPa and momentum of 32.0kg.m/s.

Figure 53 Microstructure at impact pressure of 100kPa X50 (B1) (b) at an impact pressure of 100kPa and magnification of X100 (B1)

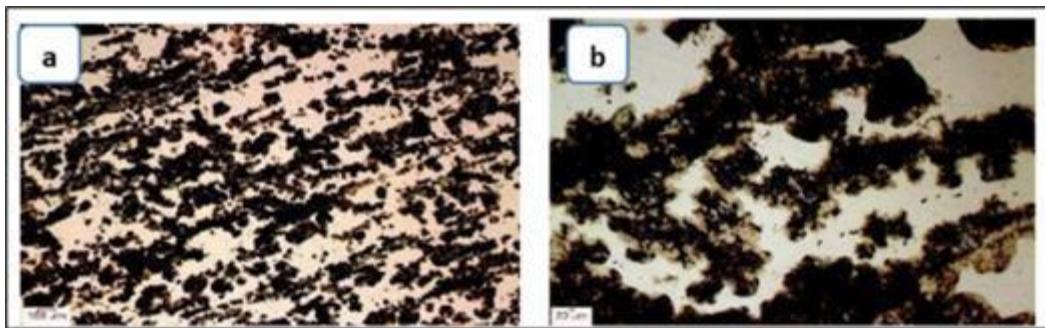
In Figure 54, no formation of shear band is noticeable but significant second phase particles are shown as well as in the higher magnification.

Figure 54 Microstructure at impact pressure of 120kPa at X100 (B2) (b) Impact pressure of 120kPa and magnification of X500 (B2)

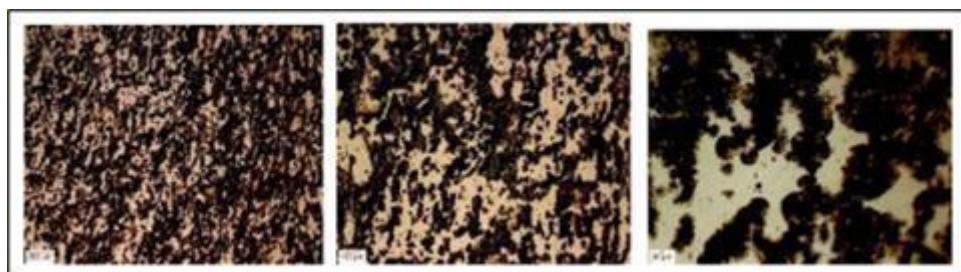
In Figure 55, at an impact pressure of 140kPa and momentum of 38.20kg.m/s, microstructure is seen to have a higher concentration of particles that are closely packed at a magnification of X50 and X100.

Figure 55 Microstructure of AA7055-T4 alloy impacted pressure at 140kPa at a magnification of X50, X100 and X500 (B3)

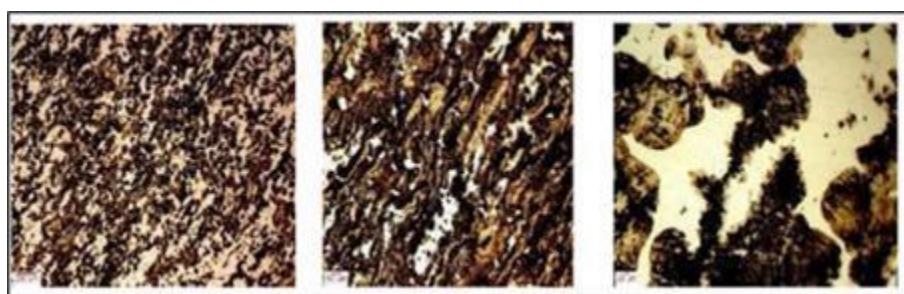
Deformation occurs at an impacted pressure of 160kPa and momentum of 49.53kg.m/s, Figure 56 shows the section of the area outside the deformed band while the adiabatic shear band can be viewed from Figure 57.

Figure 56 Microstructure of AA7055-T4 alloy impacted pressure at 160kPa at a magnification of X50, X100 and X500 (B4)

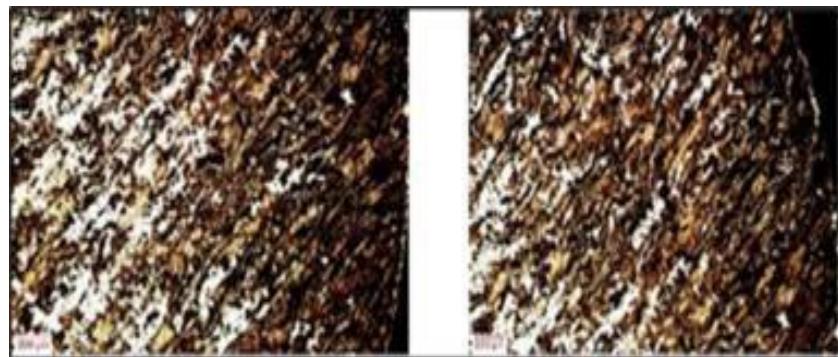
Figure 57 Shear band formed around the circumference of the AA7055-T4 alloy impacted at 160kPa at a magnification of X50 (B4)

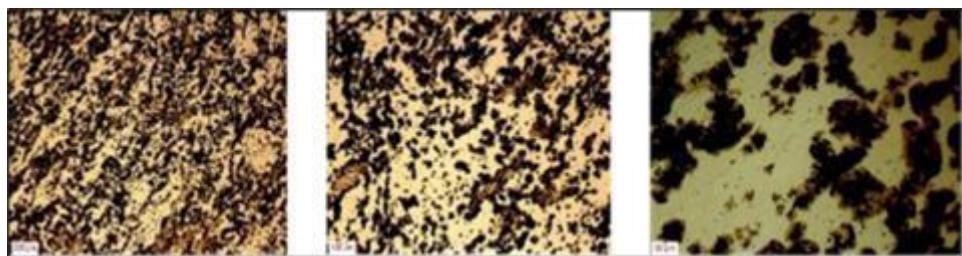
Figure 58 Microstructure of AA7055-T4 alloy at impacted pressure of 180kPa at a magnification of X50, X100, and X500 (B5)

In Figure 58, the alloy had an impact pressure of 180kPa and a momentum of 55.0kg.m/s

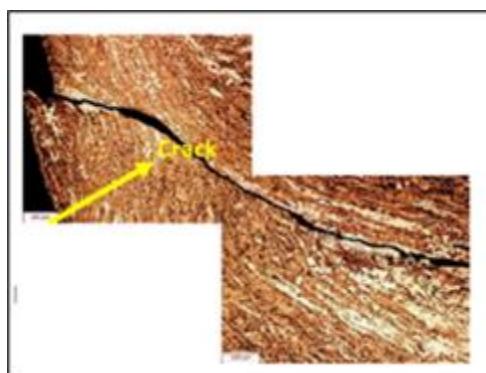
In Figure 59, crack initiation can be seen to occur at the crack tip which propagates across the material. Also, deformation of the alloy is seen with a clear adiabatic shear band shown along the crack.

Figure 59 Crack formed at the tip and across the surface specimen at a magnification of X50

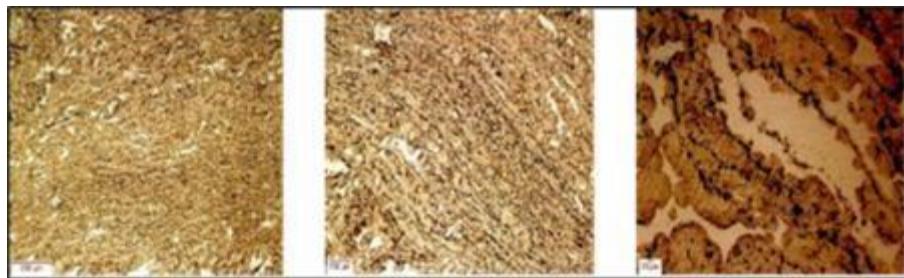
Figure 60 Microstructure of AA7055-T4 alloy showing deformed band at Magnification of X50, X100, X500

In Figure 60, deformation of the alloy can be seen in the microstructure as the concentration of the particles are closely packed.

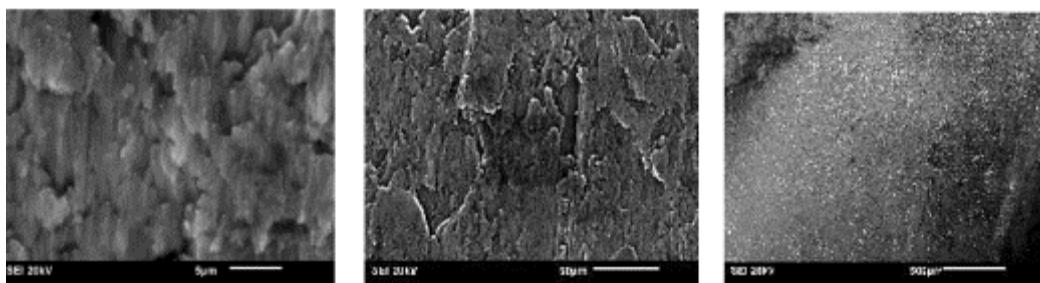
It is known that the superior combination of properties of AA7055 aluminium alloy is largely determined by the stability, morphology as well as the chemistry of the strengthening precipitates. Mondal and Mukhopadhyay studied the phases in the as-cast and homogenized AA7055 alloy and revealed that the major residual phases were $h(MgZn_2)$, $T(Al_2Mg_3Zn_3)$, $S(Al_2CuMg)$ and $\theta(Al_2Cu)$ [8]. These can be termed as the second phase particles present in the microstructure as stated in section 4.5, which enhances dislocation movement thereby strengthening the alloy. The following images of AA7055-T7751 alloy were observed with the JEOL JSM 6010LV Scanning Electron Microscope. The tempered alloy had an impact pressure of 200kPa and momentum of 36.23kg.m/s and strain rate of 1640/s at magnifications X4000, X500, and X50 as shown in Figure 61.

Figure 61 SEM images of AA7055-T7751 (AA6) inside cone at magnification of X4000, X500 and X50 respectively

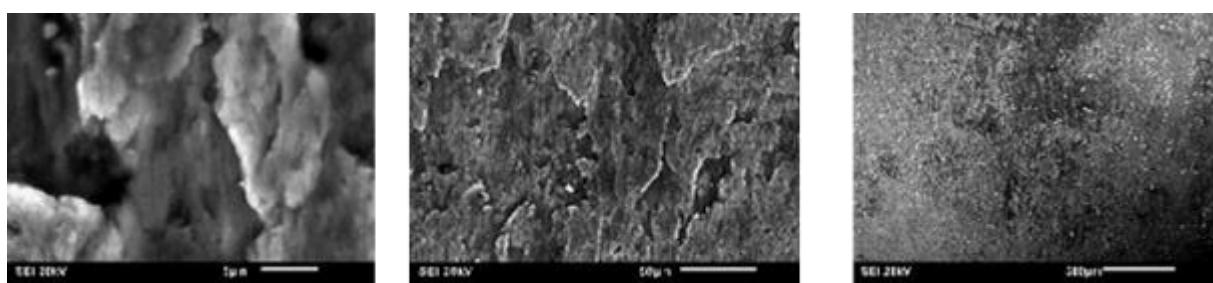
The captured images for shear band formed inside the cone of the as received AA7055-T7751 alloy is shown in the magnifications of X4000, X500 and X50 below, Figure 62.

Figure 62 SEM images of AA7055-T7751 (AA6) outside cone at magnification of X4000, X500 and X50

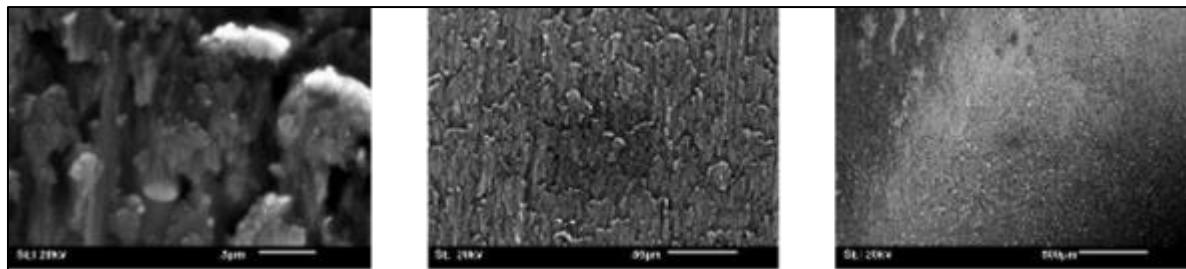
The next specimen captured is the AA7055-T6 tempered alloy impacted at a pressure of 180kPa with a momentum of 54.7kg.m/s. The captured images are shown below for both inside cones (Figure 63) and outside cone structure (Figure 64).

Figure 63 SEM images of AA7055-T6 alloy (CC5) inside cone at magnification of X4000, X500, X50 respectively

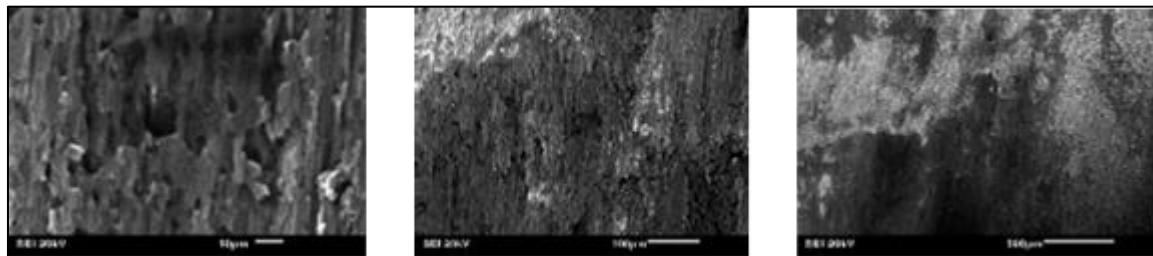
Images of the deformed T6 tempered alloy are observed outside the cone as shown below

Figure 64 SEM images of AA7055-T6 alloy (CC5) outside cone at magnification of X4000, X500, X50 respectively

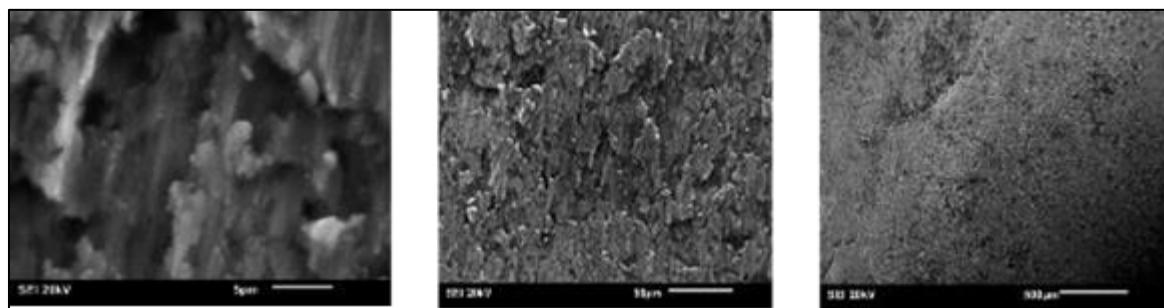
The other tempered alloy which is the AA7055-T4 was also captured. The alloy was impacted at a pressure of 180KPa and momentum of 55kg.m/s. Fracture images of the deformed band showing the inside of the cone fracture are shown for the AA7055-T4 tempered alloy below (Figure 65)

Figure 65 SEM images of AA7055-T4 alloy (B5) inside cone at magnification of X4000, X500 and X50 respectively

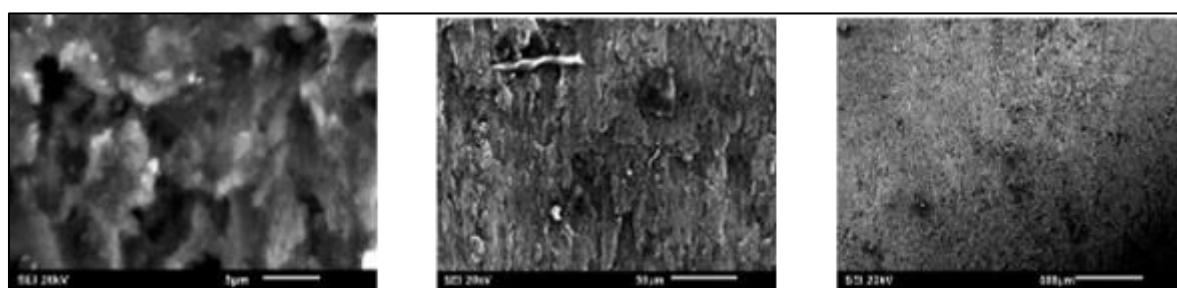
Images of the deformed T4 tempered alloy are observed outside the cone as shown below (Figure 66).

Figure 66 SEM images of AA7055-T4 alloy (B5) outside cone at magnification of X4000, X500, X50 respectively
