## Systemic seismic vulnerabilities: Key construction failures and mitigation strategies

World Journal of Advanced Engineering Technology and Sciences, 2025, 17(03), 121–128

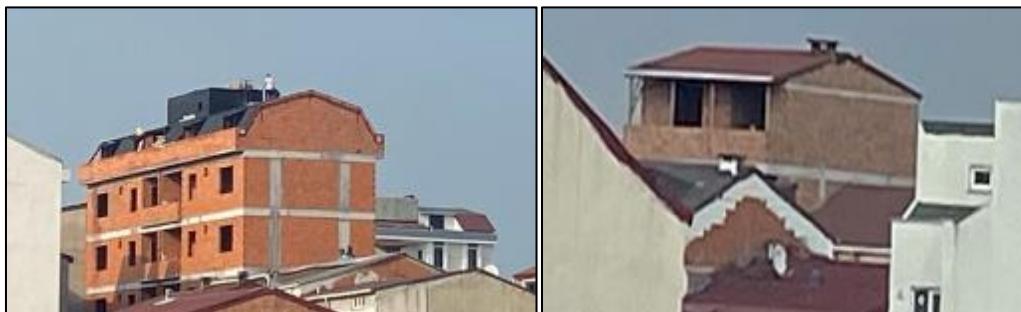
**Figure 1** Illustration of non-engineered, heavy roof construction vulnerable to seismic forces

During a seismic event, roofing systems that are excessively heavy or insufficiently engineered, Fig 1, can experience a critical loss of diaphragm integrity, meaning the roof can no longer function as a stable horizontal element capable of collecting and transferring inertial forces to the primary vertical lateral force-resisting components such as shear walls or moment frames. When this integrity is compromised, the lateral load path becomes discontinuous, causing seismic forces to concentrate erratically within the structure. The problem is further amplified when roofs are constructed with high-mass materials, as the increased dead load directly magnifies the seismic inertia forces generated during ground motion. This additional demand can push supporting members and their connections beyond their deformation and strength capacities, resulting in overstress, punching, or shear-governed failures. In extreme cases, these mechanisms may initiate localized collapse that can propagate into a progressive collapse scenario, particularly when connection detailing is inadequate or brittle. Moreover, the brittle nature of many heavy traditional roofing materials means that once failure begins, large fragments can detach suddenly, creating a severe life-safety hazard for occupants and bystanders due to falling debris and uncontrolled structural disintegration.

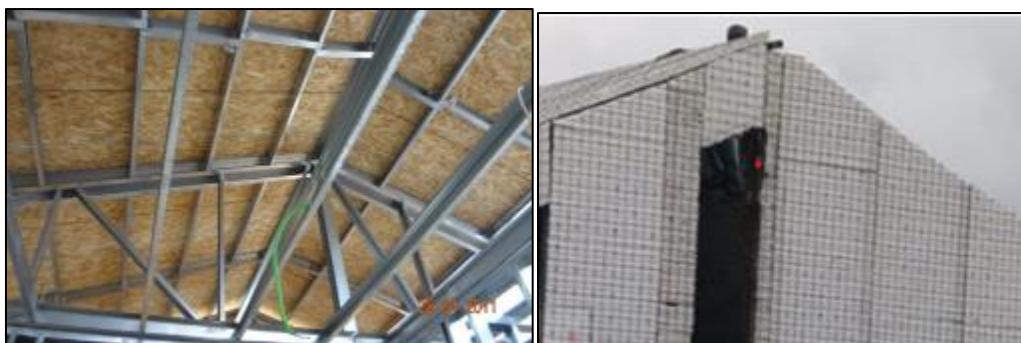
**Figure 2** Schematic of a proposed lightweight, engineered CFS (a) or 3D panel roof system (b)

To address these vulnerabilities, modern seismic engineering emphasizes the use of lightweight, ductile, and fully engineered roofing systems designed to maintain diaphragm continuity even under strong cyclic loading. Cold-formed steel (CFS), Fig 2a, roof systems offer substantial advantages, as their low mass reduces seismic demand while their ductility enhances energy dissipation and deformation capacity. These systems also rely on rigorously designed and tested connection details, ensuring a consistent, traceable load path from the diaphragm into the building's vertical resisting elements. Similarly, 3D structural panels, Fig 2b, consisting of welded steel reinforcement meshes surrounding an expanded polystyrene core, provide a high stiffness-to-weight ratio and superior energy absorption characteristics. Their integrated configuration allows them to perform effectively as both a diaphragm element and a lightweight mass-reduction solution. By adopting such engineered systems, the building experiences smaller inertia forces, more reliable force transfer, and significantly improved seismic safety and resilience.

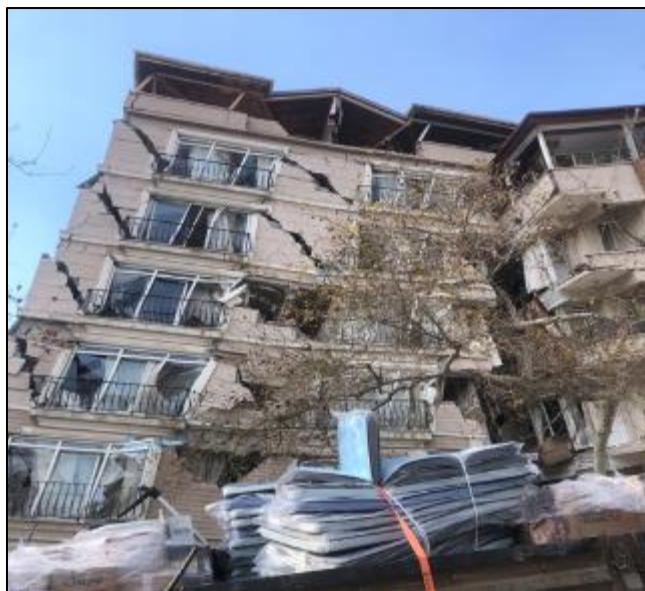
**Figure 3** Post-earthquake failure illustrating the collapse of unbraced brick partitions

Unbraced masonry infill partitions made from unreinforced brick or concrete block, Fig 3, present a major seismic vulnerability when installed within reinforced concrete frames without proper anchorage or lateral bracing, as their inherently brittle behavior renders them unable to accommodate the in-plane drift and out-of-plane accelerations generated during strong ground shaking; while the primary RC frame may survive the event, these infills are highly susceptible to sudden out-of-plane collapse, creating a direct and severe life-safety hazard from falling debris. Their failure can also severely disrupt building functionality by blocking egress paths, damaging internal spaces, and complicating emergency response and post-earthquake recovery efforts. Additionally, when infills unintentionally contribute significant stiffness to the frame—especially when irregularly distributed—they can trigger dangerous interactions such as the short-column effect, leading to concentrated shear demands and potential damage in the structural members themselves. To mitigate these risks, modern seismic practice emphasizes replacing brittle infills with engineered, ductile wall systems such as 3D structural panels—capable of acting as either sacrificial elements or fully functional shear walls to improve energy dissipation—or cold-formed steel (CFS) partition walls, Fig 4, which provide lightweight, ductile, and well-braced configurations compatible with seismic deformation demands. Where the use of infills or engineered panels is unavoidable, proper anchorage detailing becomes essential, as shear connectors must be integrated to ensure composite action between the wall and surrounding RC frame, preventing dangerous out-of-plane detachment and ensuring that any damage follows a predictable, controlled, and non-life-threatening mechanism consistent with seismic design objectives.

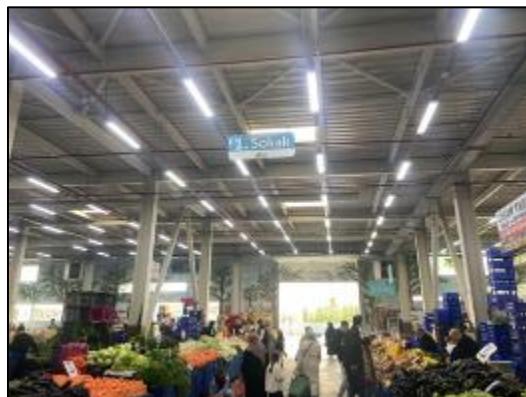
**Figure 7** Photo illustrating missing or insufficient connections between horizontal diaphragms and vertical bracing elements

A continuous, direct, and fully traceable lateral-load path is fundamental to the performance of any seismic lateral-force-resisting system, yet a frequent and serious deficiency occurs when the horizontal diaphragms—whether roof decks, concrete slabs, or metal floor systems—are not properly connected to the vertical resisting elements such as shear walls, braced frames, or moment frames, Fig 7, resulting in a discontinuity that prevents seismic inertia forces from being reliably transferred into the primary structural system. When these diaphragm-to-brace interfaces are inadequately detailed, omitted, or improperly anchored, the load path becomes fractured, forcing lateral forces to accumulate at unintended locations and creating stress concentrations that exceed the capacity of local elements. Such discontinuities also diminish the global lateral stiffness of the building, leading to increased interstory drift, heightened nonstructural damage risk, and greater vulnerability to functional disruption after an earthquake. In extreme cases, concentrated forces at weak or incomplete connections can induce brittle local failures before the global frame or wall system engages, undermining the intended seismic performance of the structure. To address these issues, modern seismic practice demands continuous and intentionally detailed bracing connections, beginning with properly designed gusset plates in steel structures that can fully transmit axial and shear forces between bracing members and diaphragm boundary elements. Roof and floor diaphragms must be positively anchored to vertical resisting systems through welded angles, shear studs, collectors, drag struts, or other engineered components that ensure uninterrupted force transfer, Fig 8. Finally, analytical verification using contemporary structural analysis tools is essential to confirm that all segments of the load path—from diaphragm shear to collector demands and brace connection strength—meet the of the design-basis earthquake and provide reliable, code-compliant seismic performance.

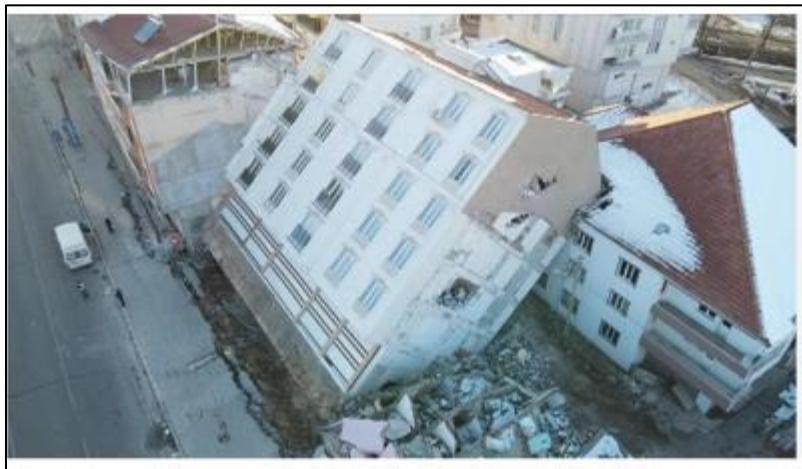
**Figure 9** Building collapses caused by soil liquefaction during the February 2023 Kahraman Maras, Turkey earthquake.[13]

Buildings constructed on loose, saturated granular soils without adequate geotechnical investigation or soil improvement are highly vulnerable to liquefaction, a seismic phenomenon in which cyclic shaking drastically reduces soil shear strength, effectively transforming the supporting ground into a fluid-like mass; this malpractice is especially widespread in rapidly developing coastal and riverine regions where foundation work is often rushed or undervalued. When liquefaction occurs, the resulting loss of bearing capacity can produce severe differential settlement across the foundation, causing buildings to tilt, distort, or suffer major structural misalignment, while more abrupt loss of support beneath isolated footings may trigger punching shear failure in foundation elements. In lighter structures or those supported on shallow pads, the reduction in soil resistance can even induce gross instability, partial overturning, or upward flotation as buoyant forces exceed the weakened soil capacity, Fig 9. To prevent such failures, modern geotechnical engineering requires implementing advanced soil-stabilization measures that enhance strength, stiffness, and drainage characteristics prior to construction. Densification techniques such as vibro-compaction, dynamic compaction, or rapid impact compaction can significantly increase relative density and improve liquefaction resistance; alternatively, installing stone columns or using deep soil-mixing methods strengthens the soil matrix and accelerates dissipation of pore water pressures. When surface improvements are insufficient, deep foundations such as piles or caissons can bypass the liquefiable zone entirely, transferring loads to competent strata at greater depths. Complementing these methods, engineered drainage systems can lower groundwater levels and provide controlled dissipation of pore pressure during seismic events, collectively forming a comprehensive mitigation strategy against liquefaction-induced damage.

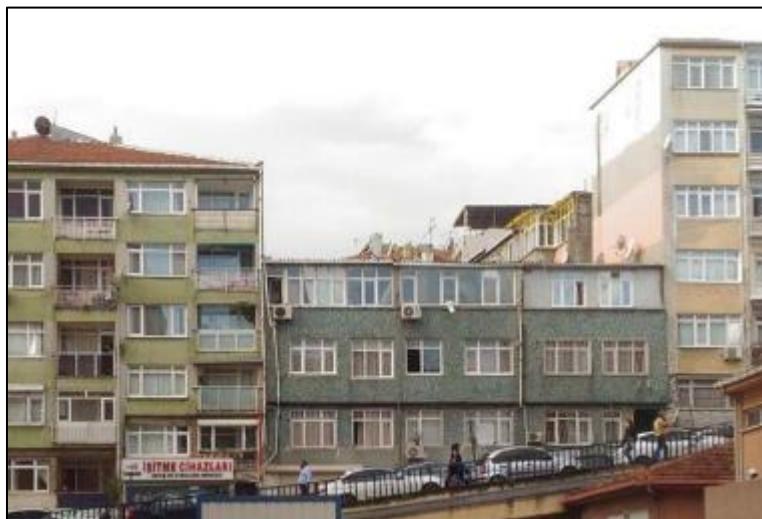
**Figure 10** Visual evidence of inadequate seismic gap between two adjacent, dissimilar structures

In densely built urban areas, a frequent and critical oversight in seismic design is the failure to provide adequate separation gaps between adjacent buildings, particularly when structures differ significantly in height, floor elevation, stiffness, or mass, creating conditions for structural contact during strong ground shaking. When gaps are insufficient, Fig 10, neighboring buildings can collide—a phenomenon known as “pounding”—which generates high localized impact forces that often cause severe damage to columns, beams, and other structural elements at the points of contact. This pounding effect can not only result in localized partial collapse but also amplify vibrations in the impacted buildings, exacerbating structural distress and potentially initiating progressive damage in otherwise sound elements. To prevent such outcomes, modern seismic design requires precise evaluation of the dynamic interaction between adjacent structures, especially in constrained urban sites, using comprehensive nonlinear dynamic analyses that account for inelastic deformation and potential relative motion. The minimum seismic separation is typically determined based on the design displacements of both buildings, often calculated using the square-root-of-sum-of-squares (SRSS) method as specified in ASCE 7-22. Where physical separation is limited, the implementation of engineered seismic joints becomes essential; these joints, filled with highly compressible and non-structural materials, accommodate relative displacements without transferring damaging forces between structures. Proper detailing, maintenance, and verification of these joints ensure continuous safety, allowing adjacent buildings to move independently during seismic

events while minimizing the risk of pounding, structural amplification, and localized collapse, thus preserving both life safety and functional integrity in densely built environments.
