Bridge assessment: A case study of Ajaokuta-Itobe Bridge, Kogi State Ibrahim

World Journal of Advanced Engineering Technology and Sciences, 2021, 02(02), 066–078

This report summarizes the assessment carried out as a result of the public uproar on the degree of safety of the Ajaokuta/Itobe Bridge in Kogi state. The public outcry was as a result of a severe damaged expansion joints of the bridge. Visual inspection and concrete strength test were carried out to ascertain the safety condition of Itobe Bridge. Seven out of the total number of eight expansion joint covers were damaged and out of place while all the elastomeric bearings were in good working condition. The scouring of the river bed was not visually pronounced except little at the abutment side of the Abuja-Ayingba approach which is attributed to change of water course. Farming activities within the vicinity of the bridge embankment has no effects on the bridge foundation. The compressive strength test result of some bridge elements selected shows that the values are within the satisfactory range. The assessment recommended the lengthening and desilting of the drainage pipes to prevent further corrosion of the concrete a

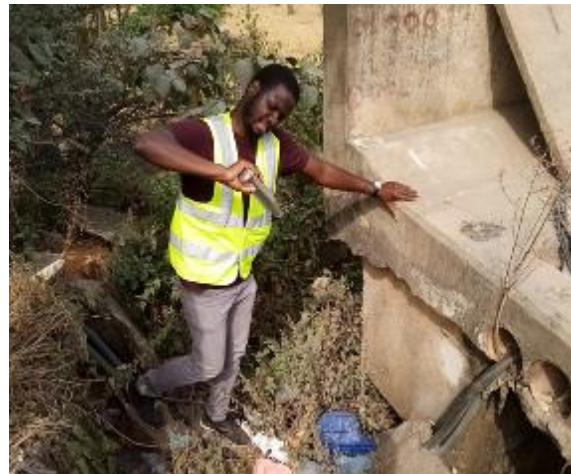
Plate 6 Concrete strength test using rebound hammer device on Bridge Abutment

Non-Destructive Test (NDT) structural integrity tests were conducted on some selected bridge components using Gilson Schmidt Concrete Test Hammer to determine the compressive strength of the concrete. The structural integrity tests
